# **GREENWOOD MEMORIAL POOL**

## **GARDNER, MASSACHUSETTS**

## **VISUAL INSPECTION AND STRUCTURAL ASSESMENT**

**BELL ENGINEERING**  
A.S. BELL ENGINEERING, P.C.  
2568 Western Avenue  
Altamont, New York 12009

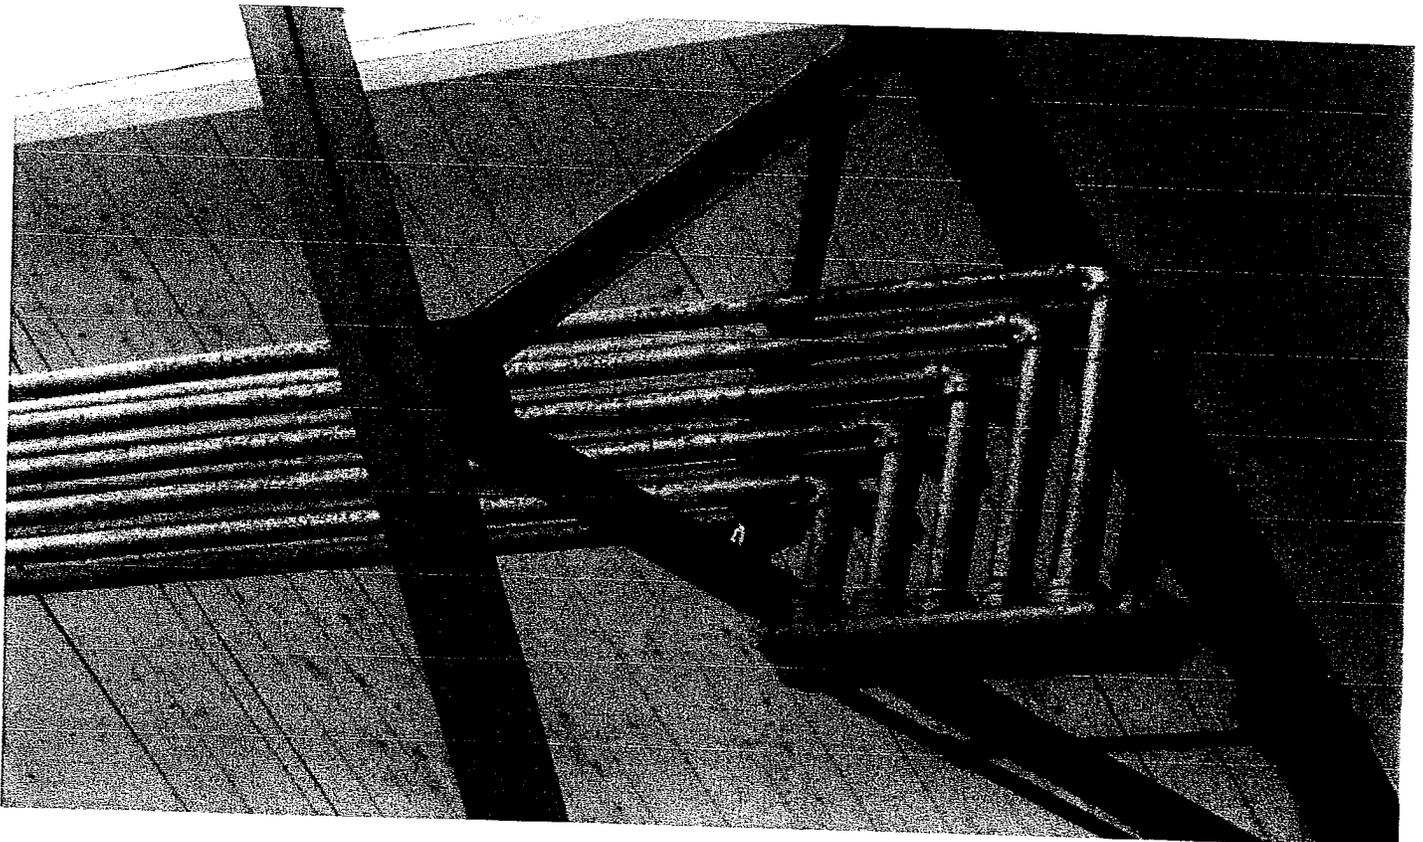
Steam heating pipes and heating fixtures are present over the pool area and are connected through the webs of the trusses. Additionally, fans and fluorescent lights are suspended from the trusses. All of this equipment is rusting, and some appear to be not working.

(2) Obsolete heating pipes and fixtures to be removed and disposed of.

The entire roof needs to be replaced. In the pool area, the roof needs to be removed down to the trusses including the 4"x 9" purlins. The heating pipes, fans and lights need to be removed and disposed of. The trusses need to be sandblasted to bare metal and repainted with zinc rich primer, moisture-cured urethane intermediate coat, with polyurethane top coat, or another industrial type paint system. During paint removal operations the entire area around the trusses needs to have complete containment due to the distinct possibility of lead-based paints existing. The skylight should be replaced with a newer, more energy efficient skylight, or windows, depending upon the desired architectural look. The purlins and sheathing need to be replaced with moisture resistant materials. If treated timber is to be used, extreme care needs to be taken to protect the trusses from the aggressive nature of the newer preservatives.

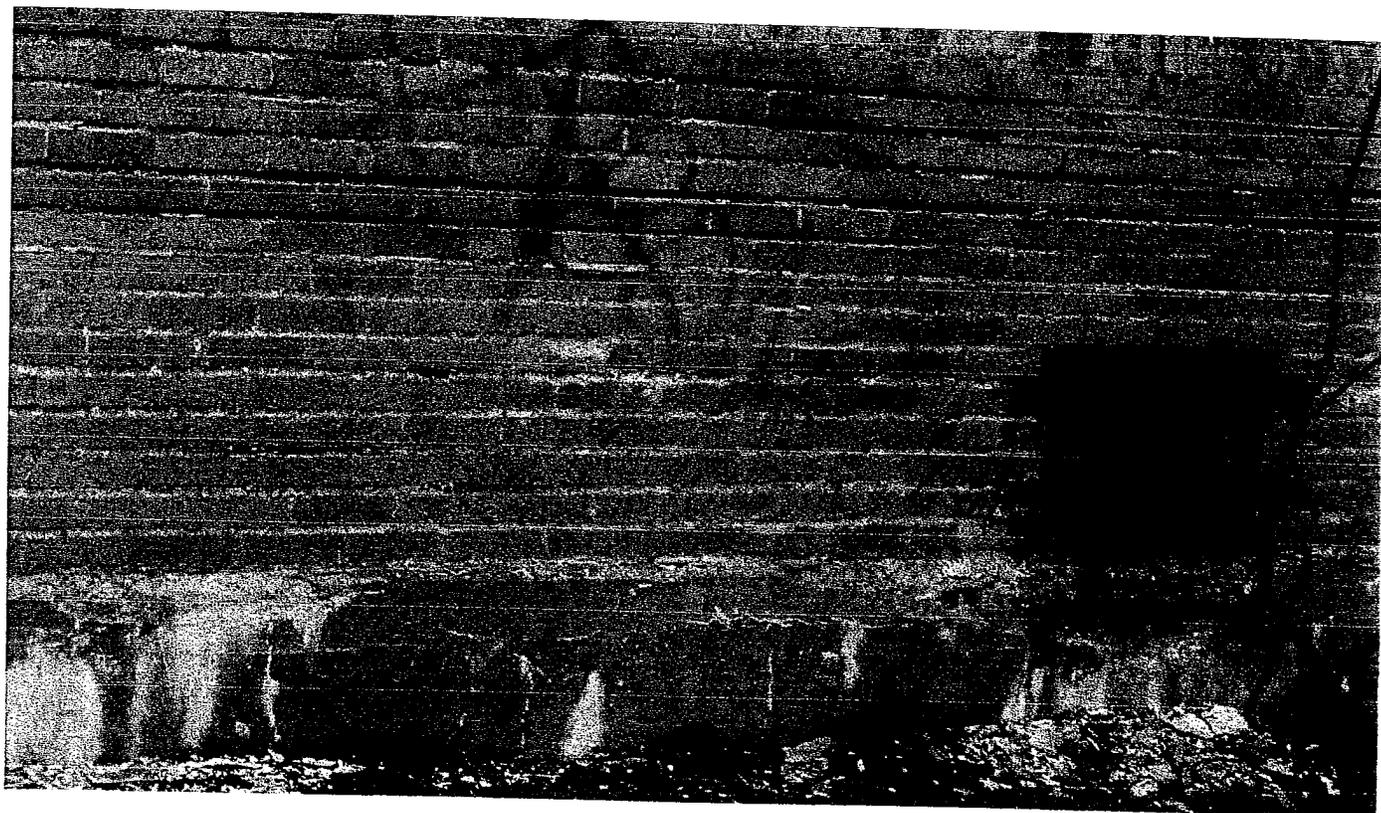
The outside masonry is in good condition except for the area from the level of the pool deck down to the top of the reinforced concrete foundation. Most of the mortar joints in this area of the pool wing are deteriorated and in need of repointing. The doorway leading out from the north end of the pool on the right (east) side has an area of deterioration under the doorway sill. There is a general deterioration of the mortar of the masonry in this area, to the point where the masonry under the door has dropped, and diagonal cracks through the mortar joints extend over the doorway frame. This deterioration extends around the corner of the wall to the east side.

(6) General deterioration of mortar around the exterior walls.

Masonry repairs are required around the east door at the north end of the pool building. In addition, the mortar joints for approximately five (5') feet above the concrete foundation need repair. Concrete repairs to the foundation are required below this joint with the masonry.

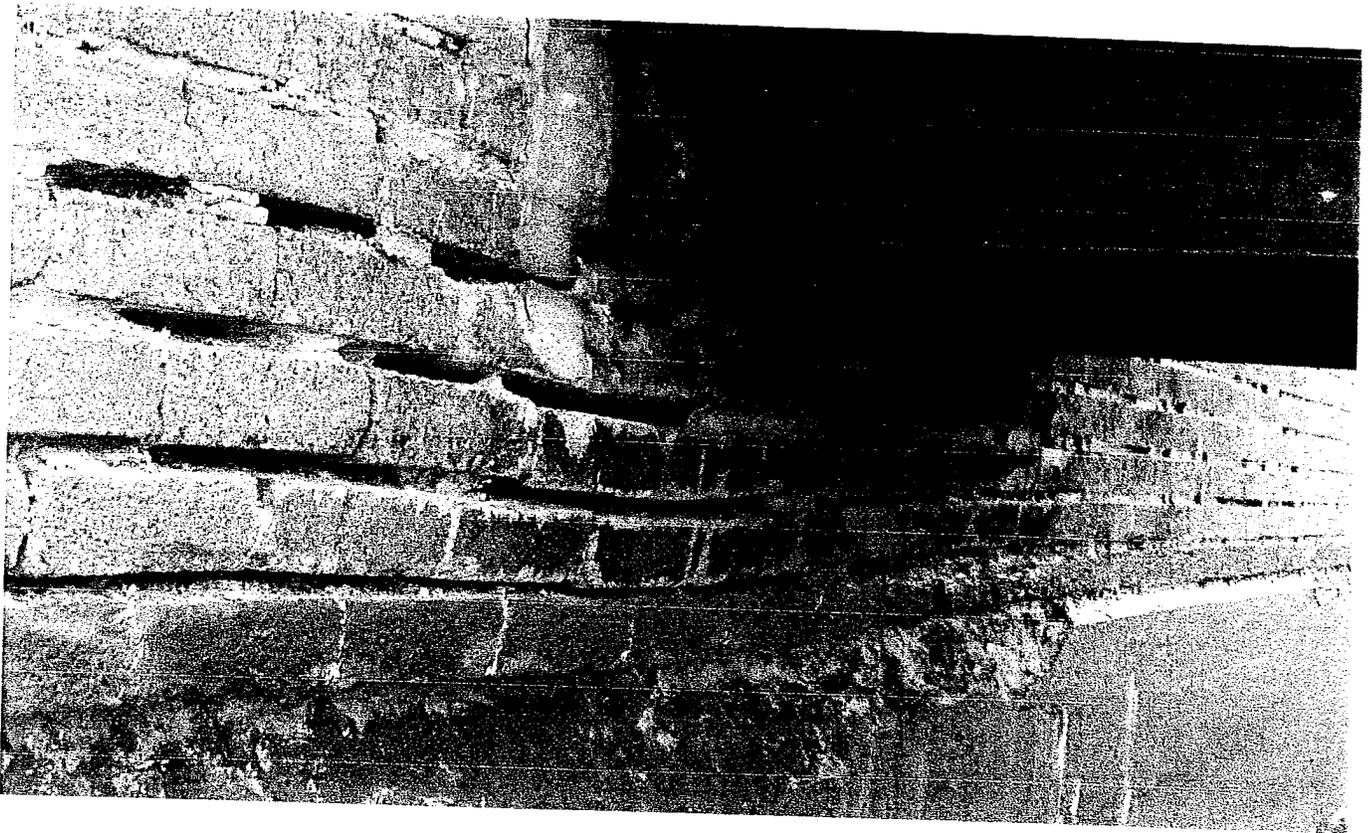
(7) Masonry under the door in the north end of the building has dropped.

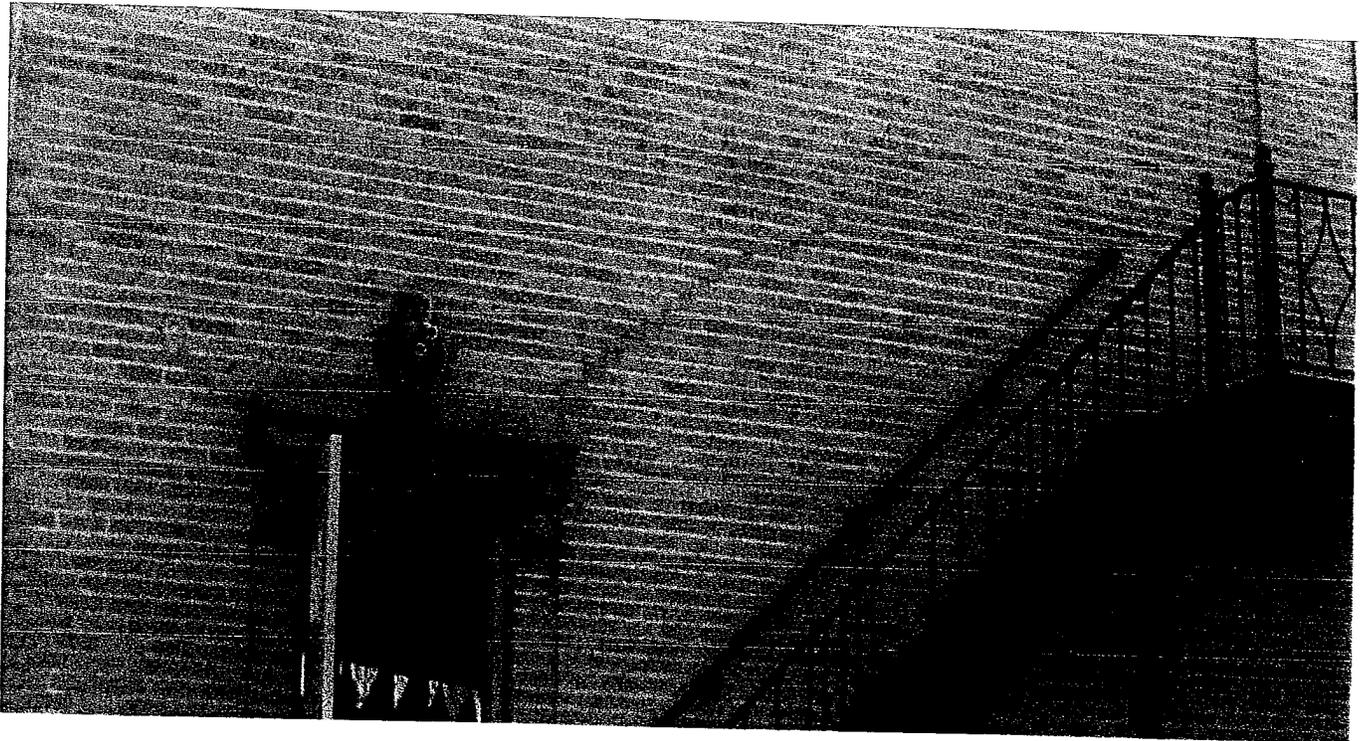
(8) Diagonal cracks in motor joint over door frame on the north side of building.

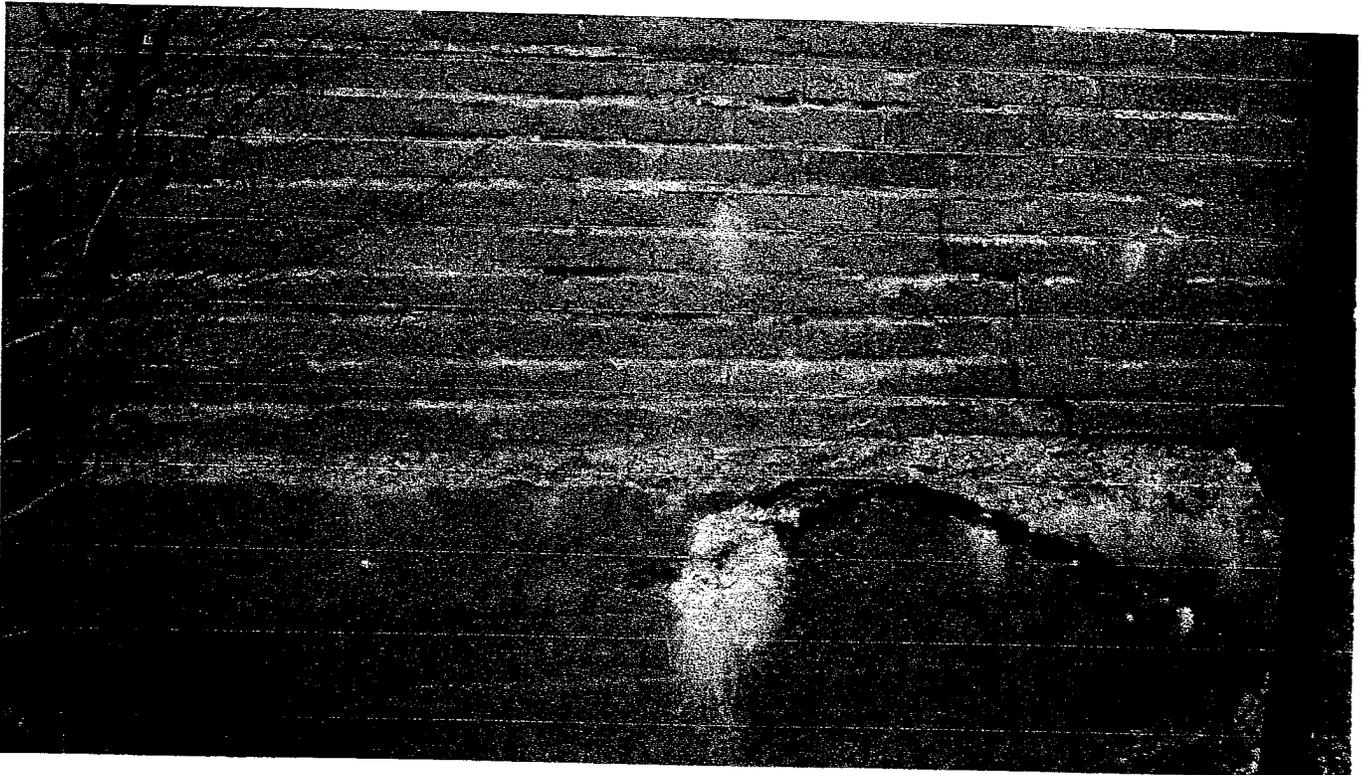
(10) Concrete deterioration in the foundation.
