Perry Auditorium and
Greenwood Memorial Bathhouse
Gardner, MA

Final Building Assessment Report

**The City of Gardner
Massachusetts**

March 2010

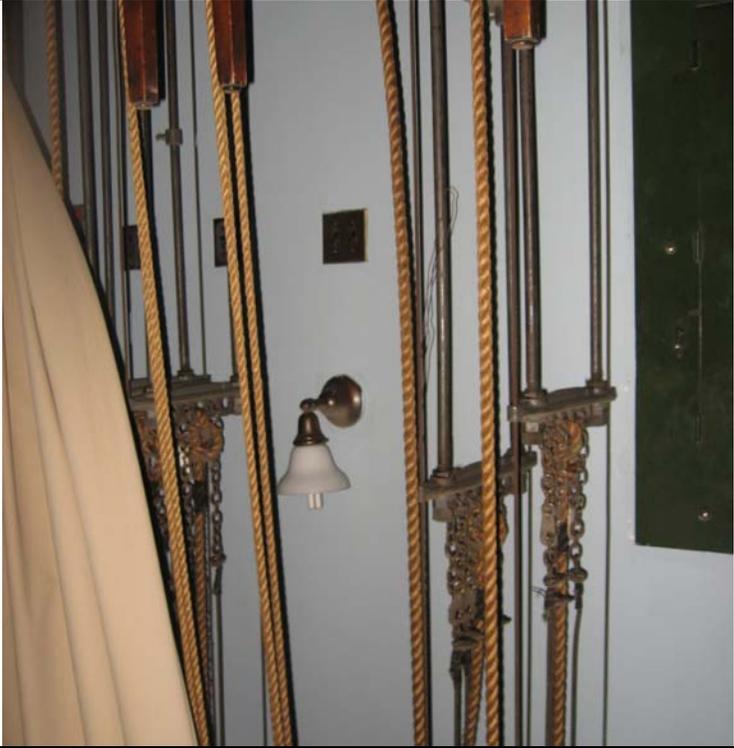
Tighe&Bond		PHOTOGRAPHIC LOG	
Client Name: City of Gardner, MA		Site Location: Perry Auditorium, Gardner, MA	
		Project No. G-0384	
Photo No. 2	Date: 11/25/09

Direction Photo Taken:			
Description: Stage area lighting

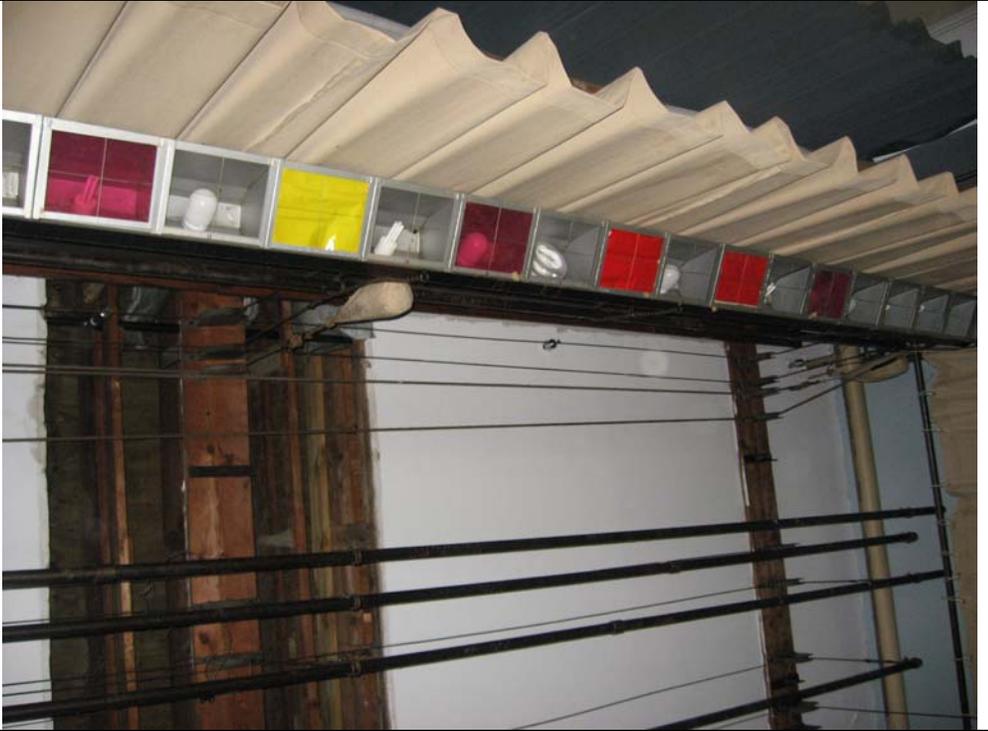
Tighe&Bond		PHOTOGRAPHIC LOG	
Client Name: City of Gardner, MA		Site Location: Perry Auditorium, Gardner, MA	
		Project No. G-0384	
Photo No. 3	Date: 11/25/09

Direction Photo Taken:			
Description: Stage lighting overhead

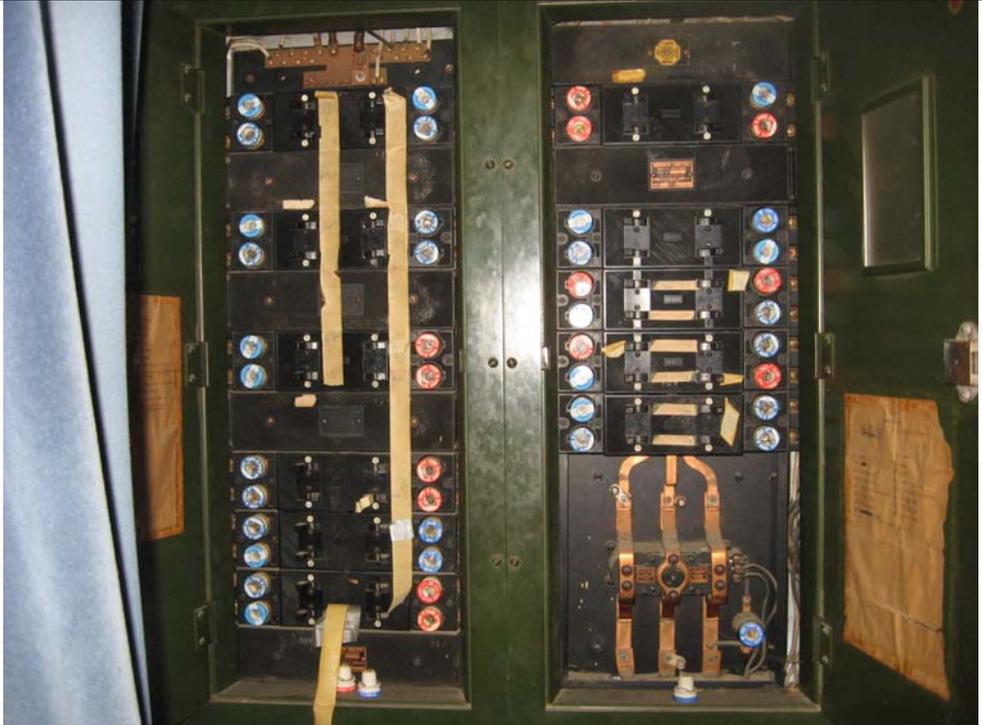
Tighe&Bond		PHOTOGRAPHIC LOG	
Client Name: City of Gardner, MA		Site Location: Perry Auditorium, Gardner, MA	Project No. G-0384
Photo No. 6	Date: 11/25/09

Direction Photo Taken:			
Description: Stage area electrical panelboards

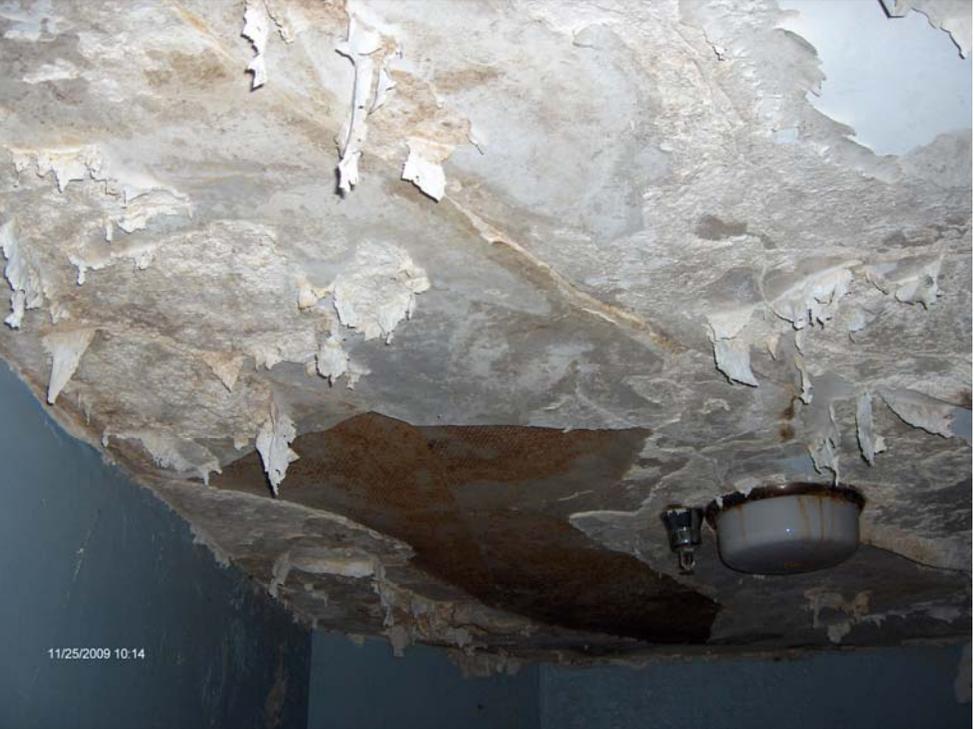
Tighe&Bond		PHOTOGRAPHIC LOG	
Client Name: City of Gardner, MA		Site Location: Perry Auditorium, Gardner, MA	Project No. G-0384
Photo No. 1	Date: 11/25/09

Direction Photo Taken:			
Description: Deteriorated plaster in west stairs.

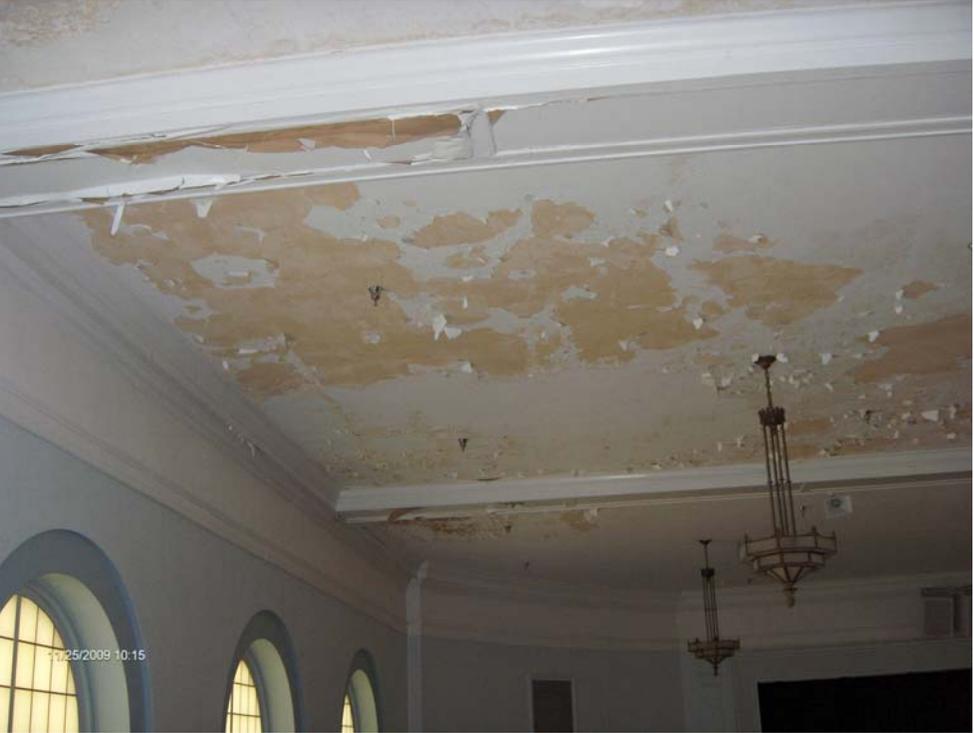
Tighe&Bond		PHOTOGRAPHIC LOG	
Client Name: City of Gardner, MA		Site Location: Perry Auditorium, Gardner, MA	Project No. G-0384
Photo No. 2	Date: 11/25/09

There were indications of water damage throughout the building as evidenced by numerous areas of peeling and crumbling plaster ceilings, several areas where the finished wood flooring was heaving, and mold was observed on some of the wall board. Through our conversations, City personnel confirmed the building has experienced leaking from the existing wood roof resulting in water damage to the ceilings and wood floors. The City indicated previous repairs have been made to the roof in an attempt to prevent further deterioration of the building. Based on observations made during the site visit, it appears the leaks have been addressed as evidence of new water damage was not present.

Direction Photo Taken:			
Description: Peeling and deteriorated plaster on main auditorium ceiling.

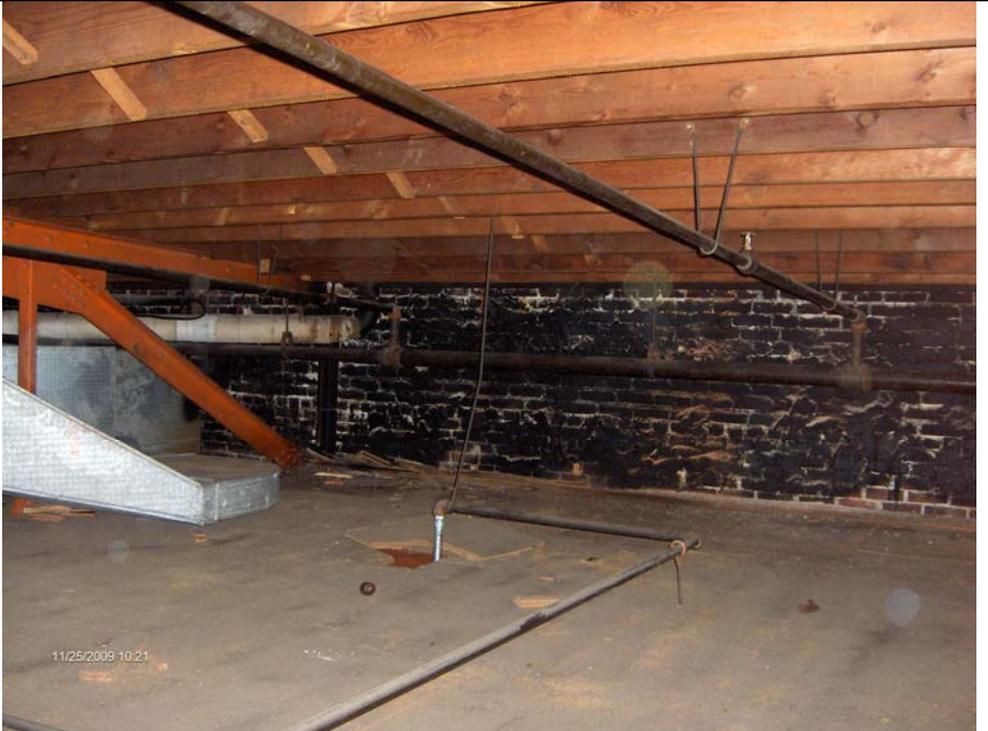
Tighe&Bond		PHOTOGRAPHIC LOG	
Client Name: City of Gardner, MA		Site Location: Perry Auditorium, Gardner, MA	Project No. G-0384
Photo No. 5	Date: 11/25/09

Direction Photo Taken:			
Description: Deteriorated edge of wood and exterior wall

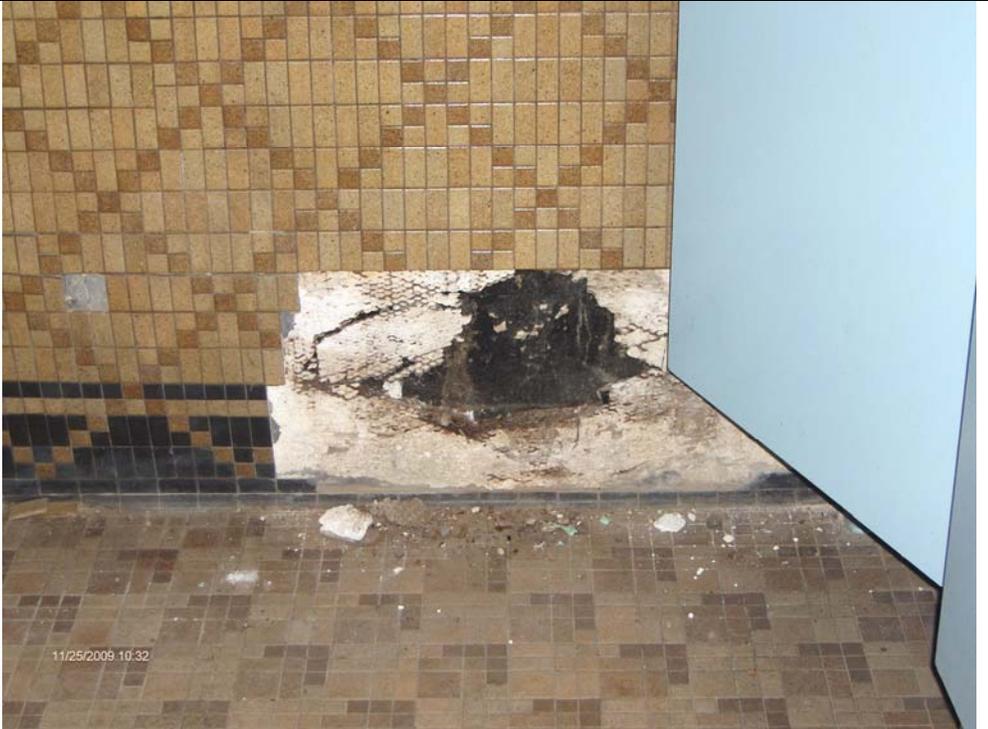
Tighe&Bond		PHOTOGRAPHIC LOG	
Client Name: City of Gardner, MA		Site Location: Perry Auditorium, Gardner, MA	Project No. G-0384
Photo No. 6	Date: 11/25/09

Direction Photo Taken: Southwest			
Description: Deteriorated and spalled concrete at basement level.

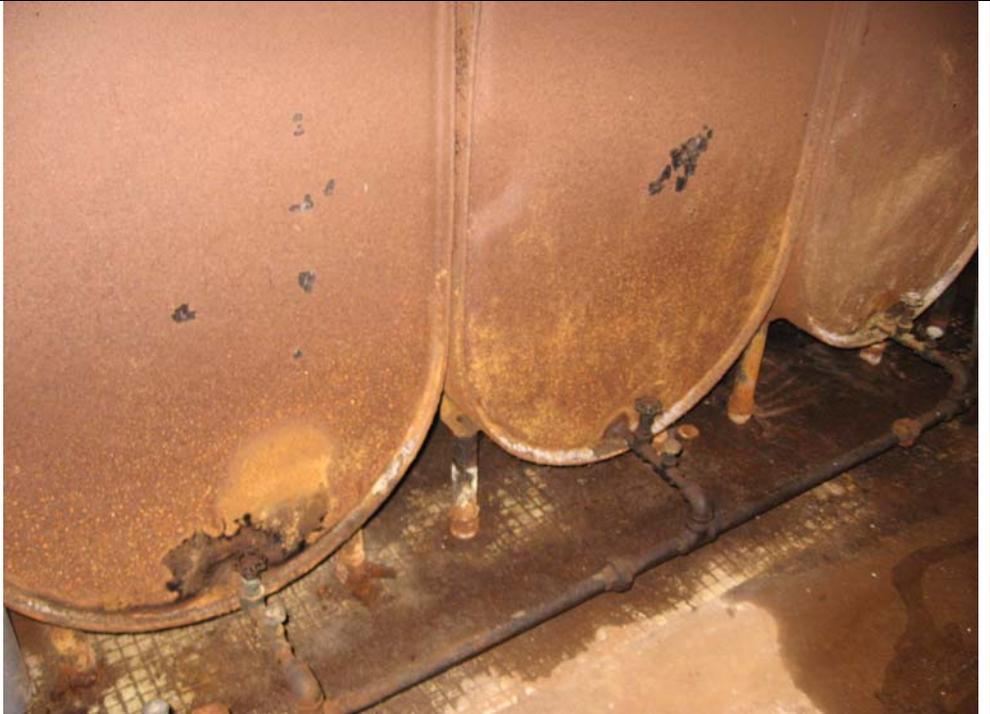
Direction Photo Taken:			
Description: Fuel oil tanks corrosion

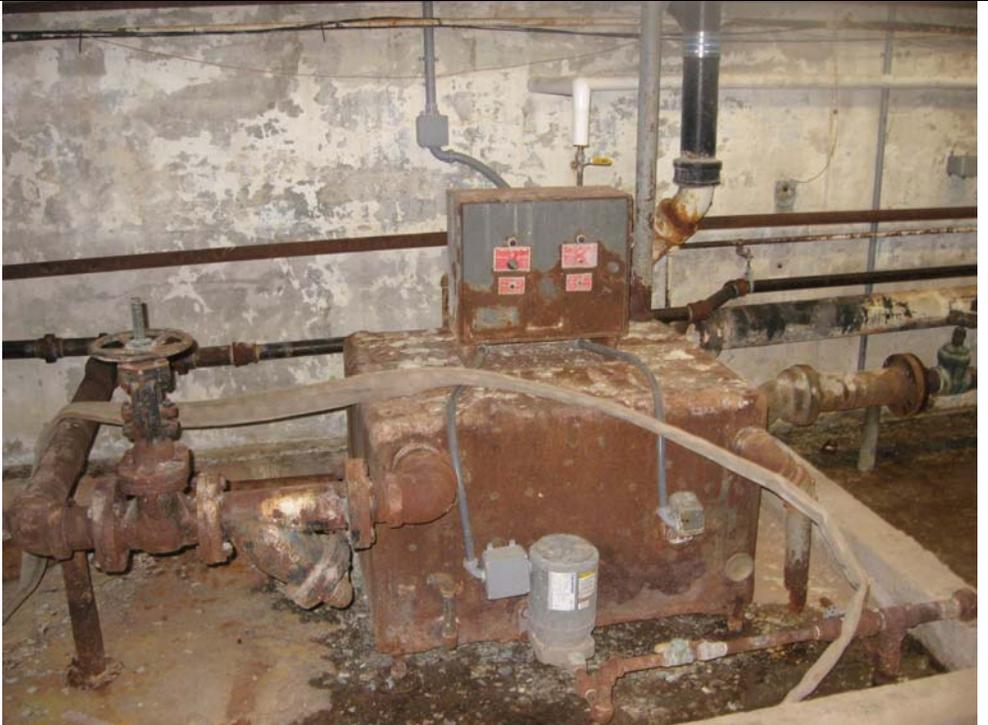
Direction Photo Taken:			
Description: Steam condensate pump set – bad corrosion

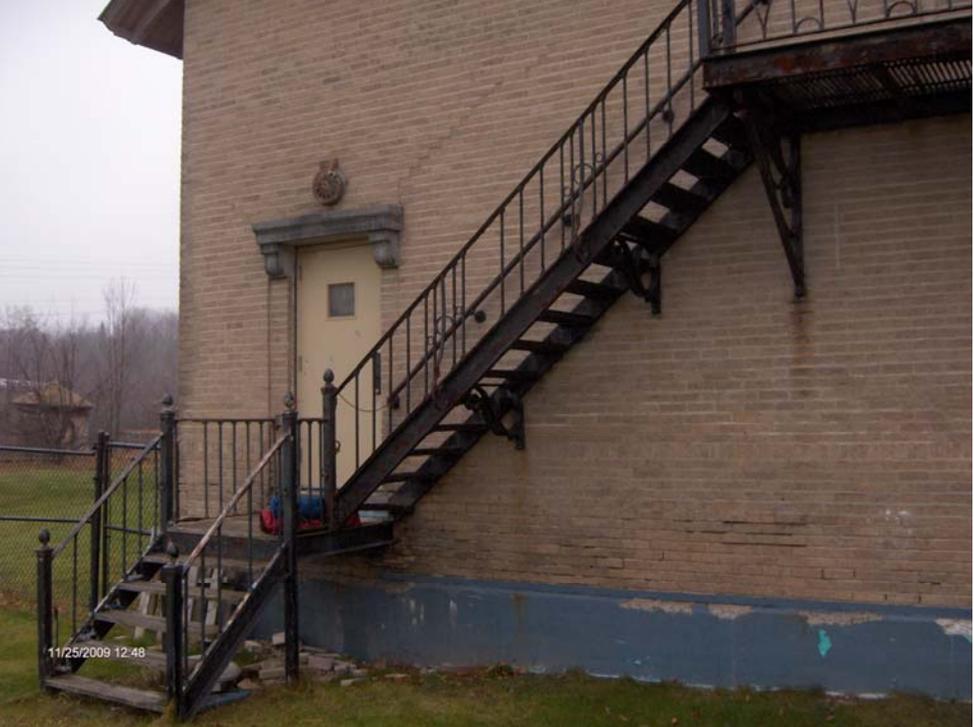
Tighe&Bond		PHOTOGRAPHIC LOG	
Client Name: City of Gardner, MA		Site Location: Greenwood Memorial Bathhouse, Gardner, MA	Project No. G-0384
Photo No. 4	Date: 11/25/09

Direction Photo Taken:			
Description: West exterior wall with diagonal cracks and failed masonry

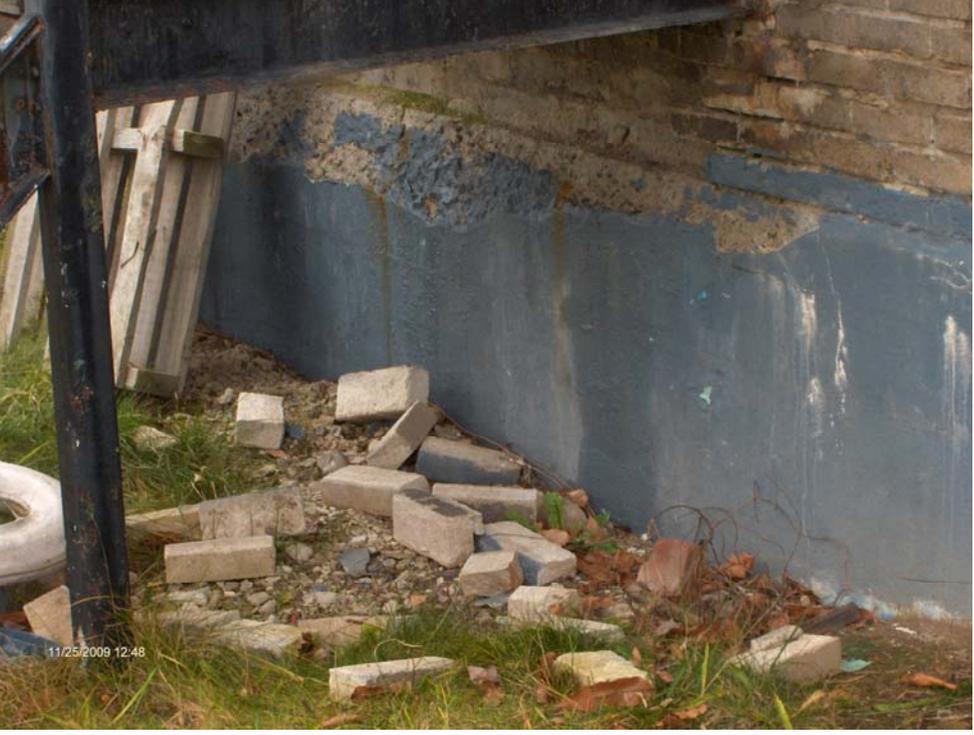
On the exterior side of the west exit door there is substantial damage to both the masonry wall and the concrete foundation. Significant erosion of the concrete, caused by weathering and potentially exacerbated by calcium chloride from the pool, has exposed the aggregate as well as the reinforcing steel in several areas. In addition, there are numerous cracks with efflorescence along the north and west sides of the building's foundation.

Direction Photo Taken:			
Description: West all with failed masonry and spalled concrete foundation

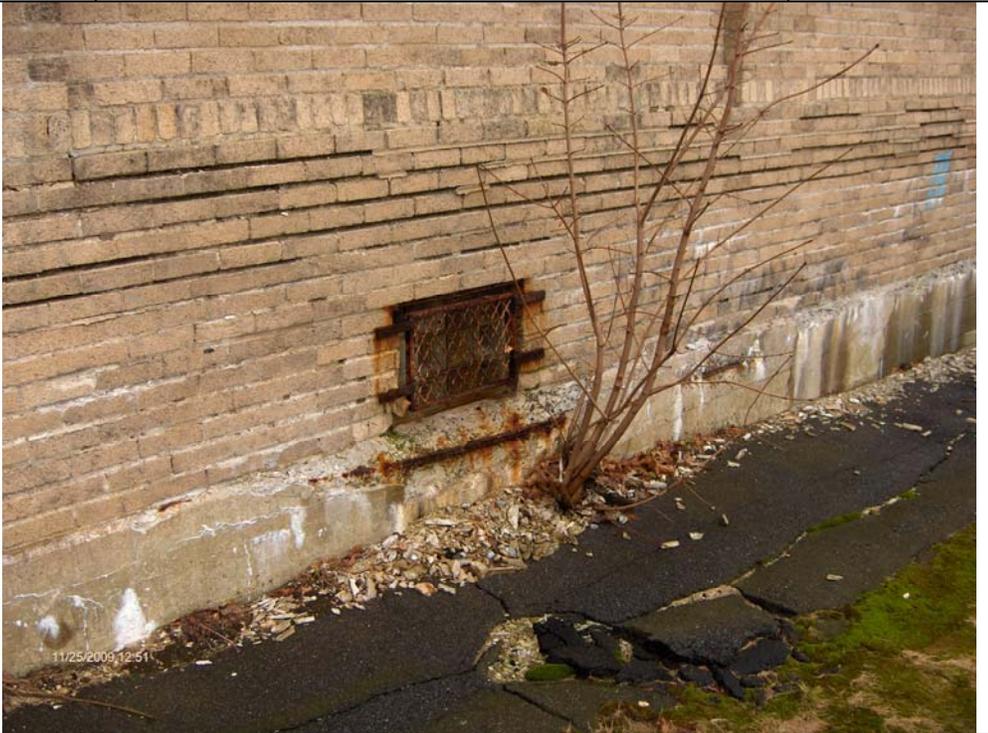
Direction Photo Taken:			
Description: North wall with deteriorated and spalled concrete and failing masonry

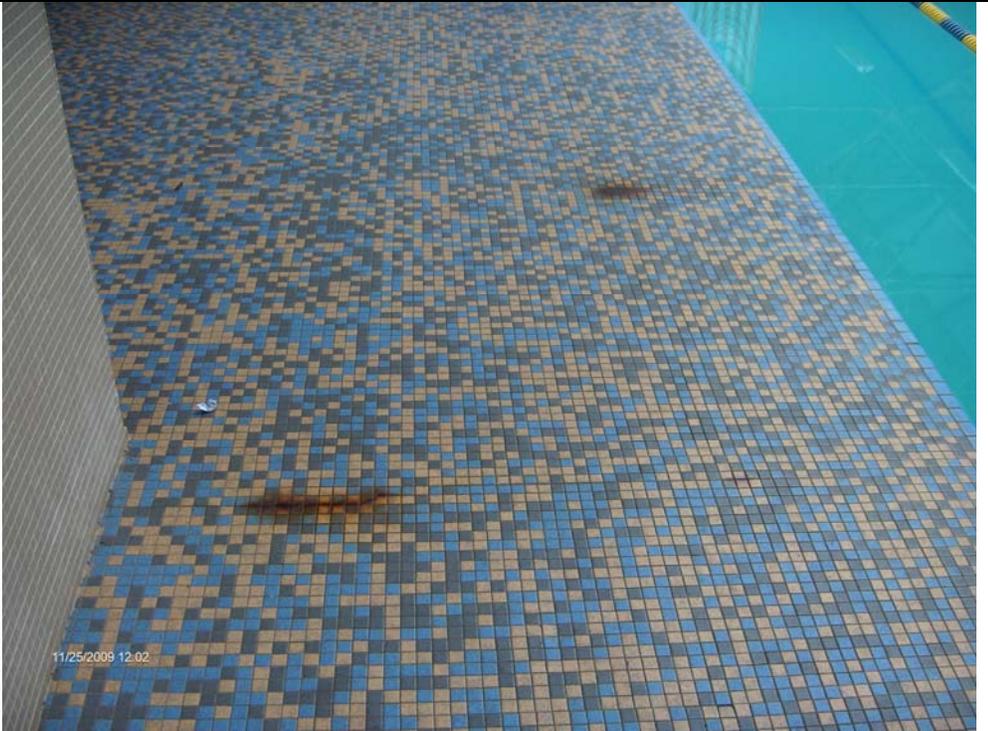
Direction Photo Taken:			
Description: Rust stains on elevated structural slab

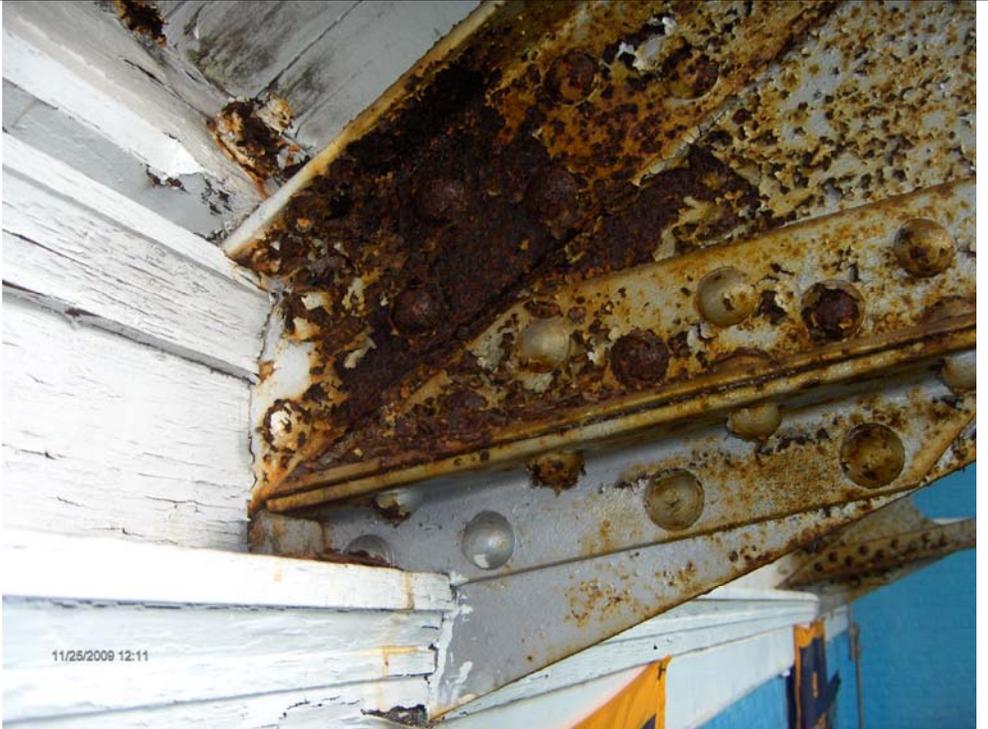
Direction Photo Taken:			
Description: Rusted truss end bearing with section loss
