Perry Auditorium and
Greenwood Memorial Bathhouse
Gardner, MA

Final Building Assessment Report

**The City of Gardner
Massachusetts**

March 2010

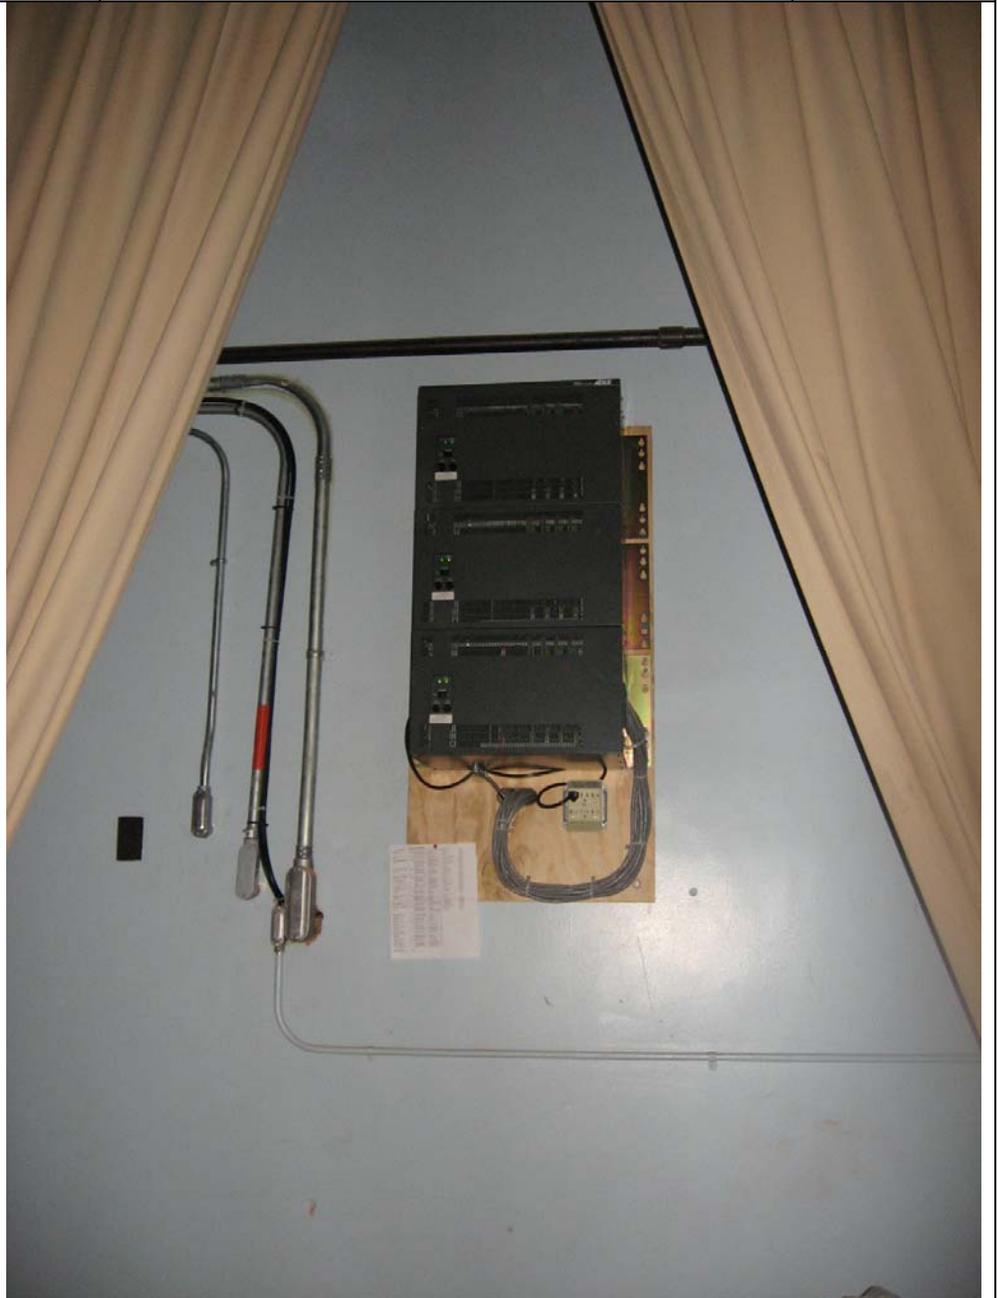
Stage area tele/data systems

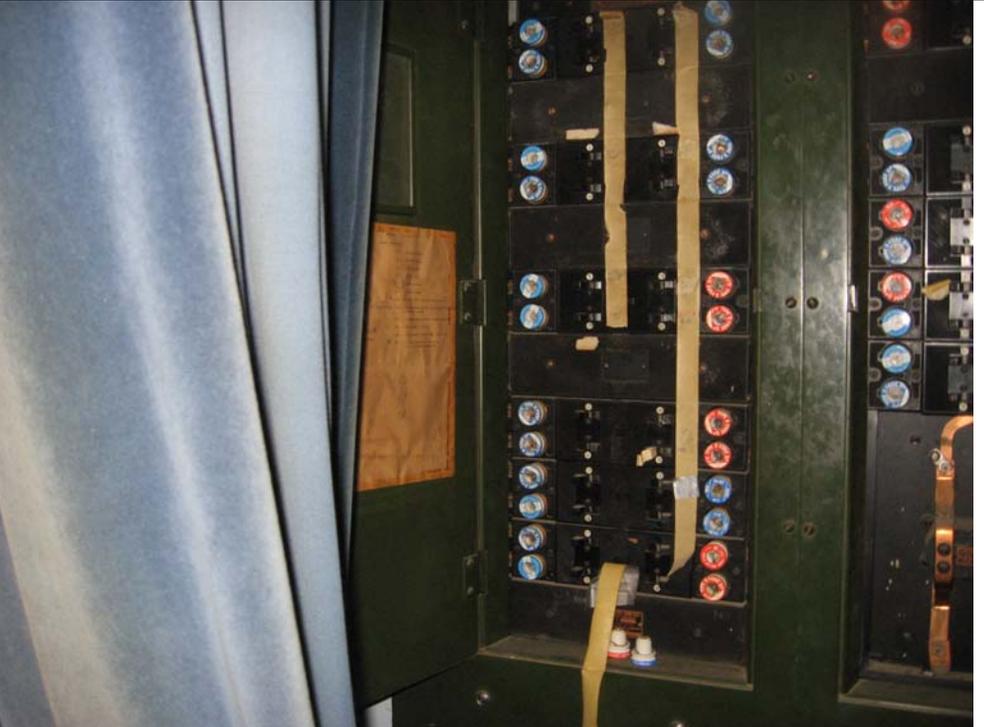
Tighe&Bond		PHOTOGRAPHIC LOG	
Client Name: City of Gardner, MA		Site Location: Perry Auditorium, Gardner, MA	Project No. G-0384
Photo No. 4	Date: 11/25/09

Direction Photo Taken:			
Description: Stage area mechanical system control equipment

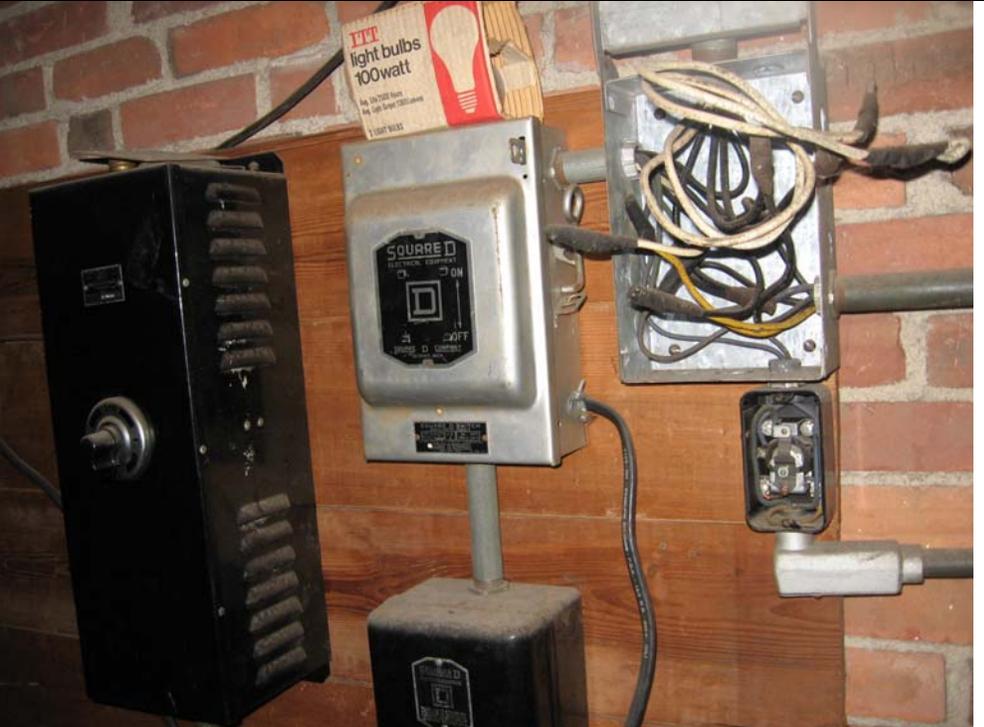
Tighe&Bond		PHOTOGRAPHIC LOG	
Client Name: City of Gardner, MA		Site Location: Perry Auditorium, Gardner, MA	Project No. G-0384
Photo No. 5	Date: 11/25/09

Direction Photo Taken:			
Description: Stage area mechanical system control equipment

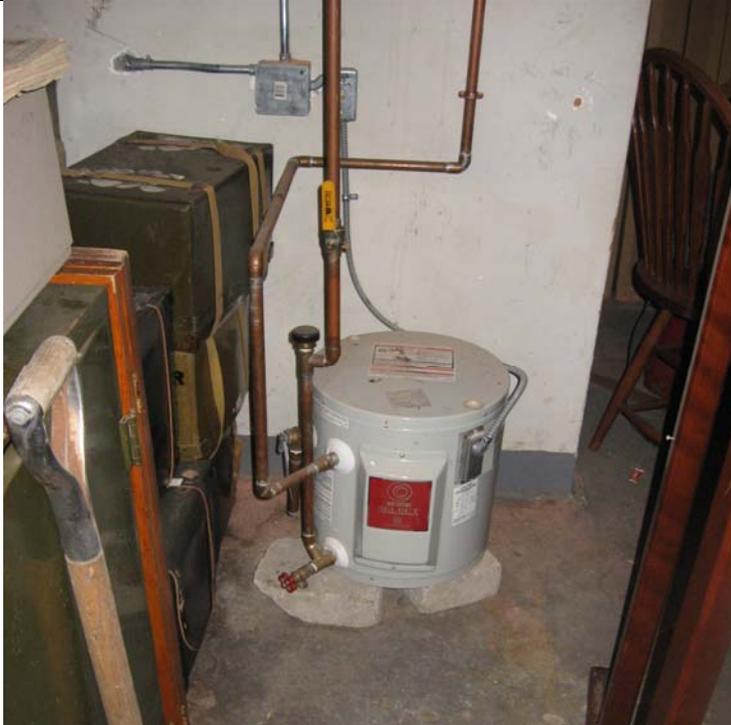
Tighe&Bond		PHOTOGRAPHIC LOG	
Client Name: City of Gardner, MA		Site Location: Perry Auditorium, Gardner, MA	Project No. G-0384
Photo No. 7	Date: 11/25/09

Direction Photo Taken:			
Description: Domestic hot water heater

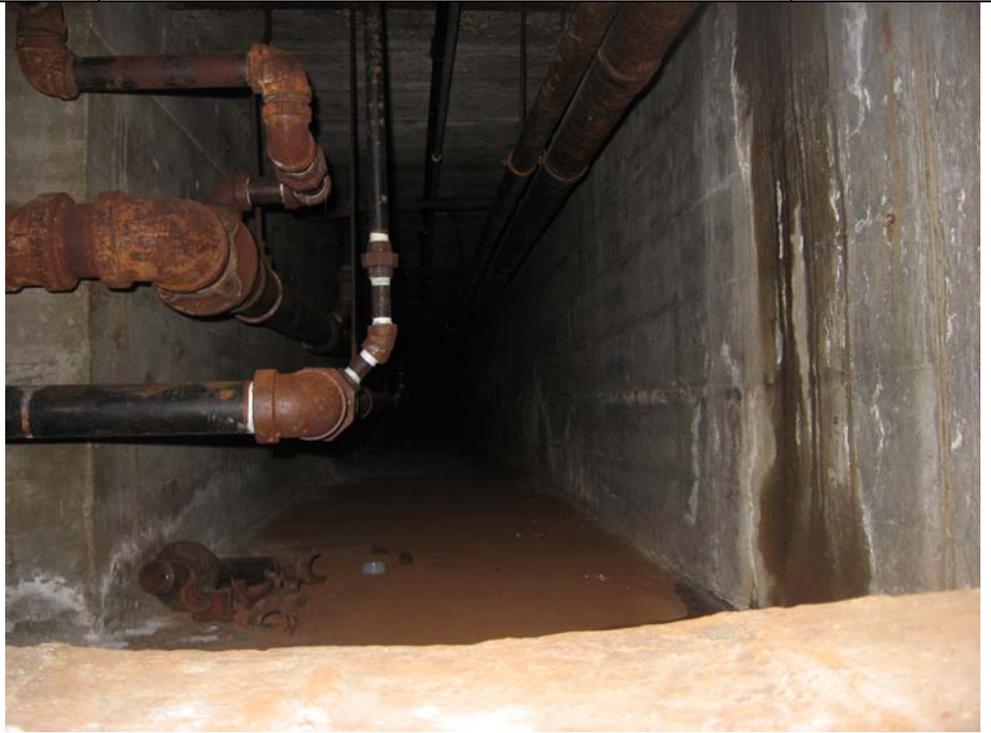
Mechanical equipment with various piping systems, waste water heating and domestic water

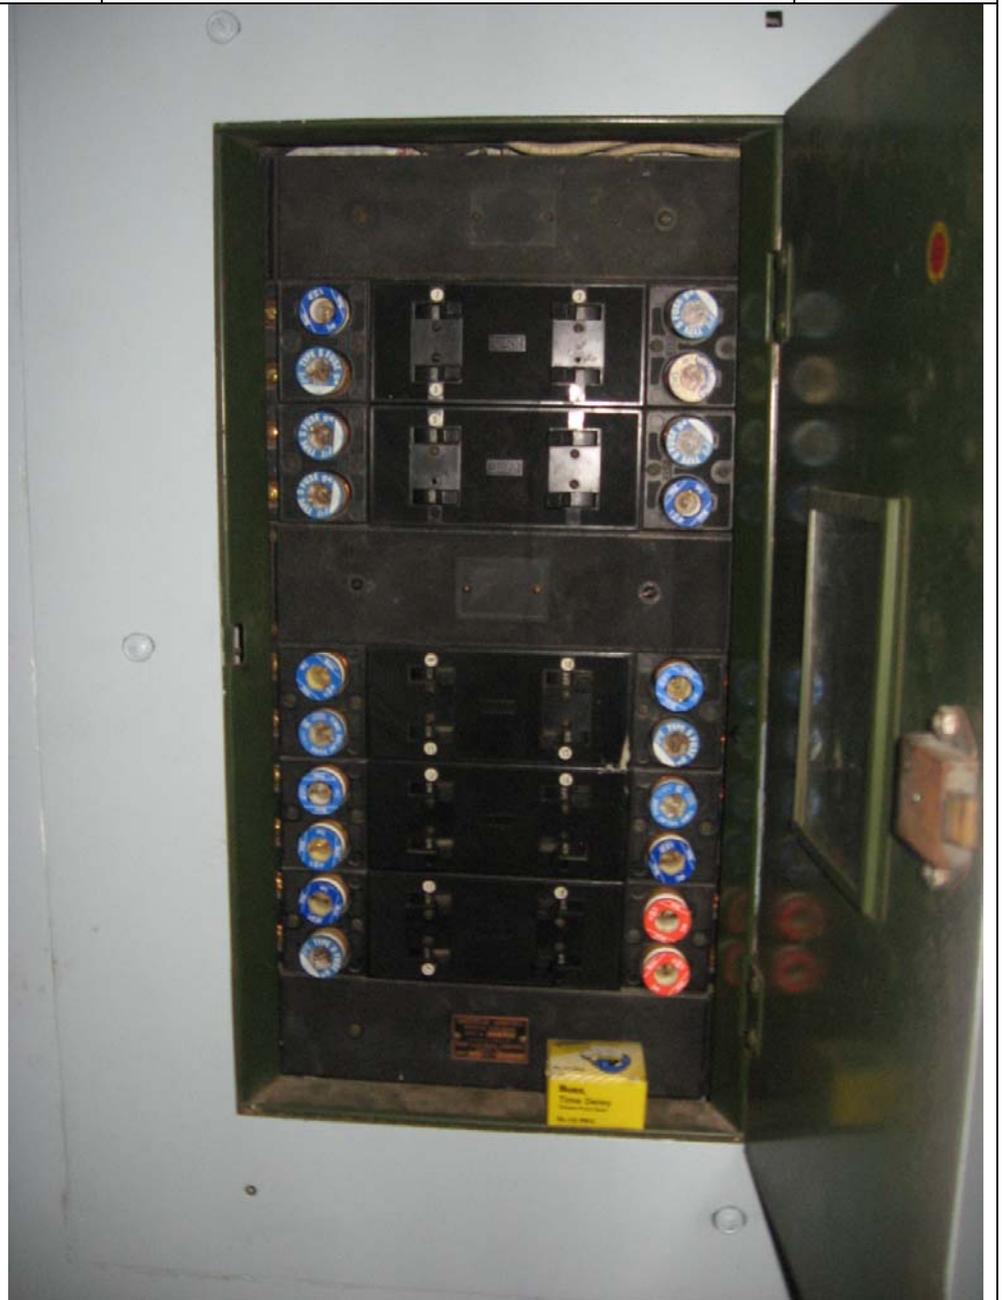
Photo No.
9**Date:**
11/25/09**Direction Photo Taken:****Description:**

Lighting panelboard

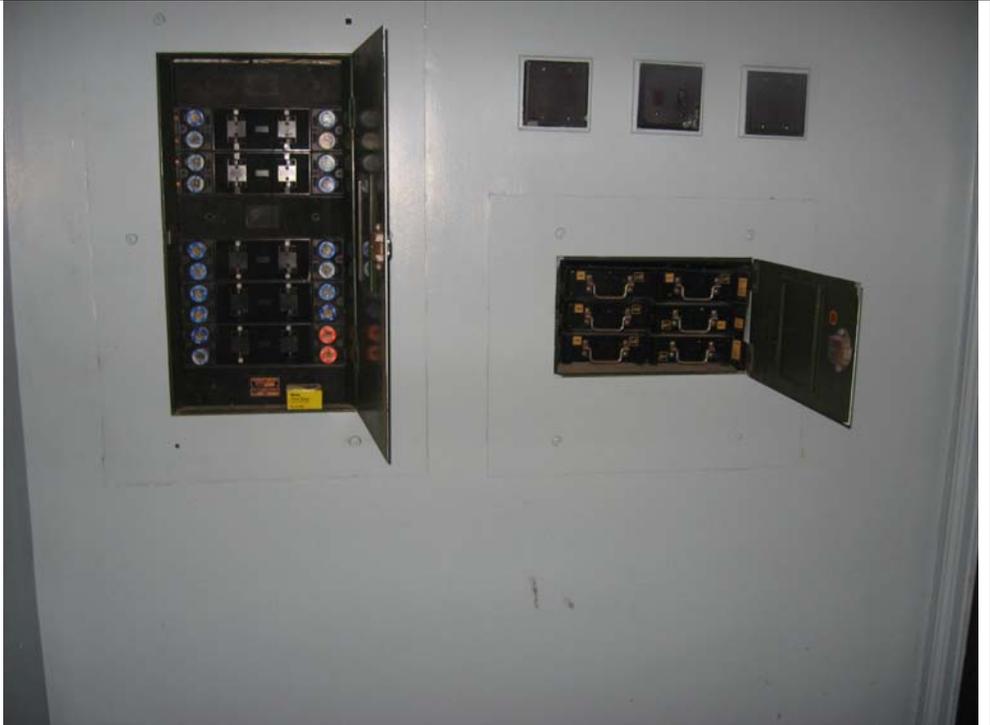
Tighe&Bond		PHOTOGRAPHIC LOG	
Client Name: City of Gardner, MA		Site Location: Perry Auditorium, Gardner, MA	Project No. G-0384
Photo No. 10	Date: 11/25/09

Direction Photo Taken:			
Description: Basement level electrical panelboards

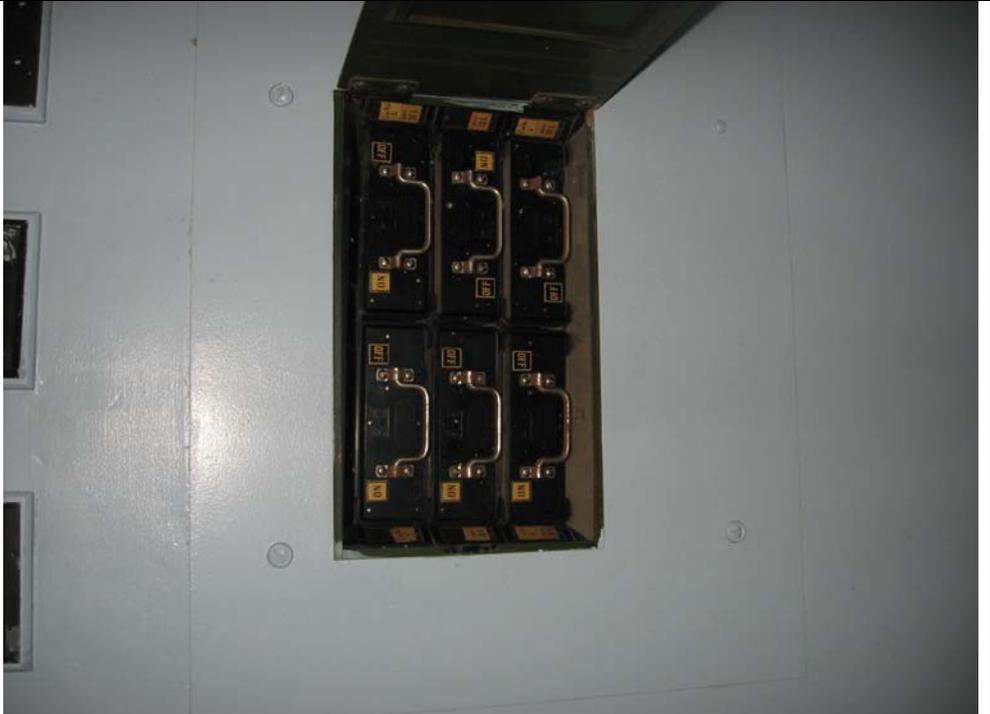
Tighe&Bond		PHOTOGRAPHIC LOG	
Client Name: City of Gardner, MA		Site Location: Perry Auditorium, Gardner, MA	Project No. G-0384
Photo No. 11	Date: 11/25/09

Direction Photo Taken:			
Description: Mechanical equipment panelboard

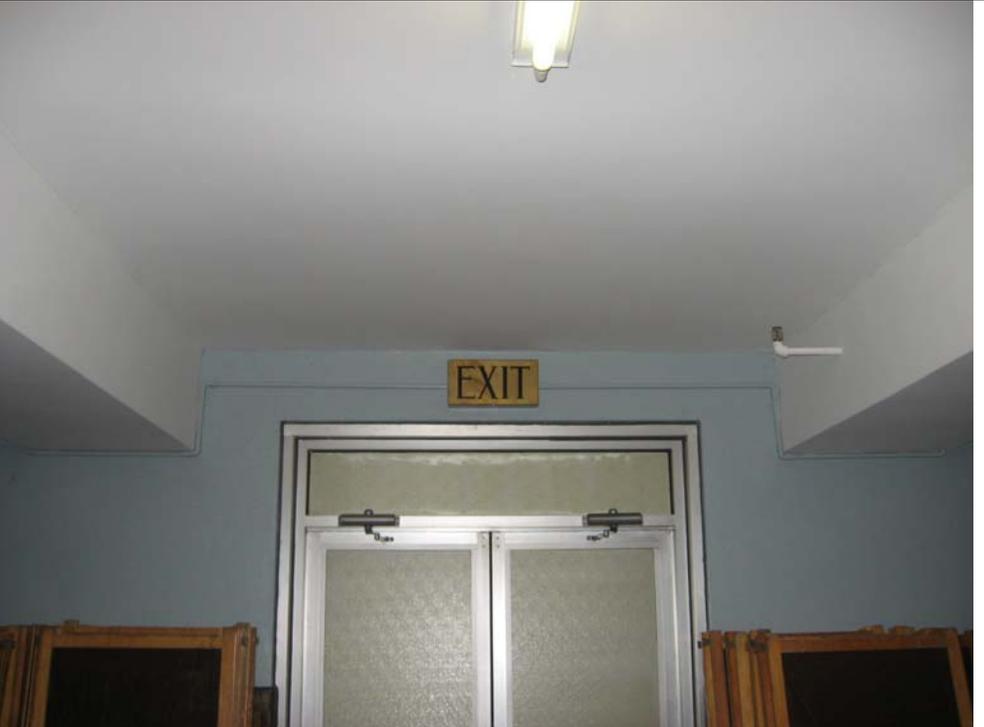
Tighe&Bond		PHOTOGRAPHIC LOG	
Client Name: City of Gardner, MA		Site Location: Perry Auditorium, Gardner, MA	Project No. G-0384
Photo No. 14	Date: 11/25/09

Direction Photo Taken:			
Description: Base level lighting, exit lighting and sprinkler protection

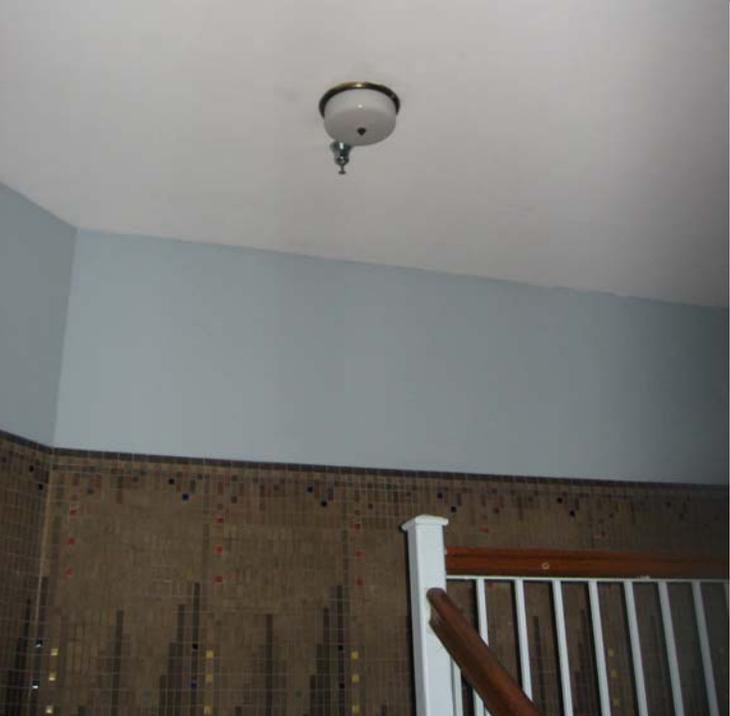
Tighe&Bond		PHOTOGRAPHIC LOG	
Client Name: City of Gardner, MA		Site Location: Perry Auditorium, Gardner, MA	Project No. G-0384
Photo No. 15	Date: 11/25/09

Direction Photo Taken:			
Description: Stairwell lighting

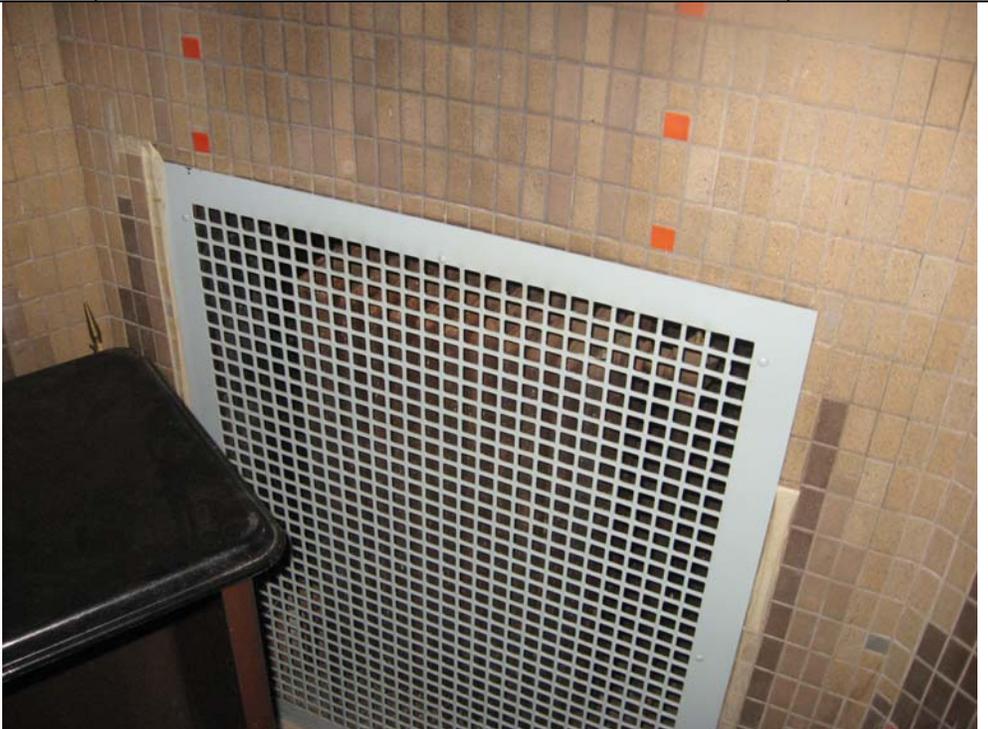
Tighe&Bond		PHOTOGRAPHIC LOG	
Client Name: City of Gardner, MA		Site Location: Perry Auditorium, Gardner, MA	Project No. G-0384
Photo No. 16	Date: 11/25/09

Direction Photo Taken: Southwest			
Description: Restroom heating

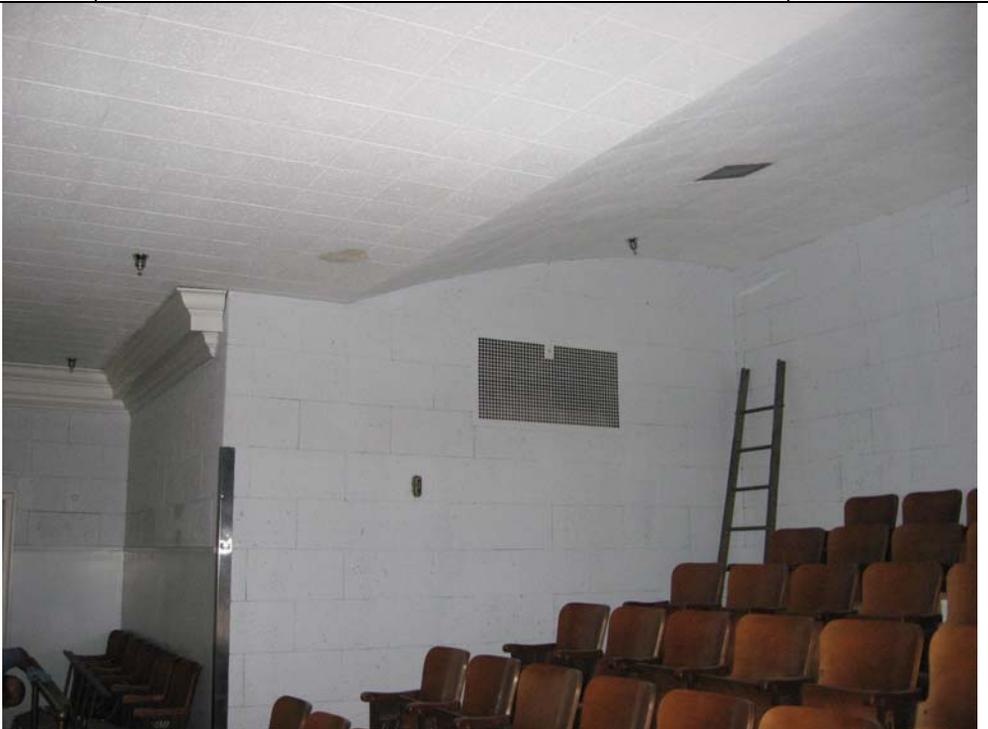
Tighe&Bond		PHOTOGRAPHIC LOG	
Client Name: City of Gardner, MA		Site Location: Perry Auditorium, Gardner, MA	Project No. G-0384
Photo No. 17	Date: 11/25/09

Direction Photo Taken:			
Description: Balcony ventilation

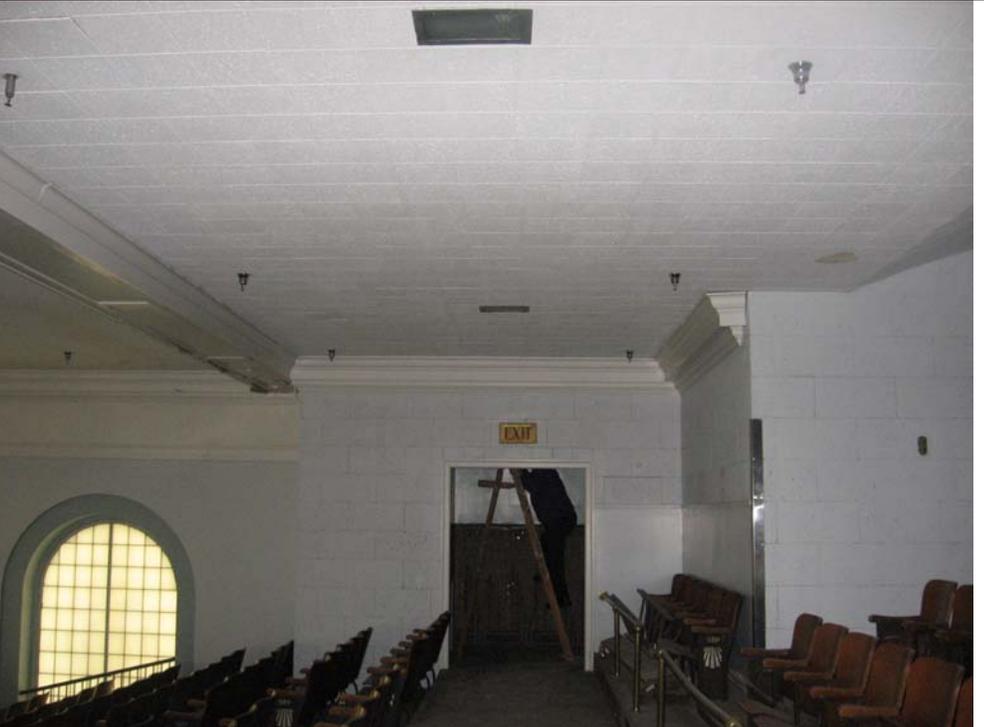
Tighe&Bond		PHOTOGRAPHIC LOG	
Client Name: City of Gardner, MA		Site Location: Perry Auditorium, Gardner, MA	Project No. G-0384
Photo No. 18	Date: 11/25/09

Direction Photo Taken:			
Description: Balcony area lighting, exit lighting and sprinkler protection

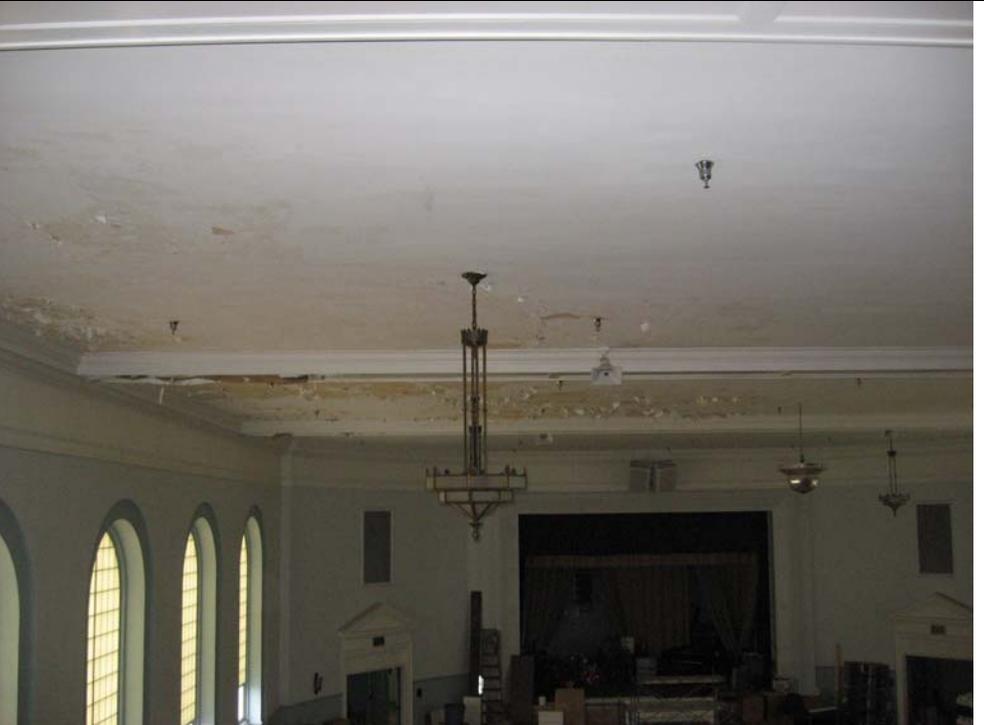
Tighe&Bond		PHOTOGRAPHIC LOG	
Client Name: City of Gardner, MA		Site Location: Perry Auditorium, Gardner, MA	Project No. G-0384
Photo No. 19	Date: 11/25/09

Direction Photo Taken:			
Description: Auditorium lighting

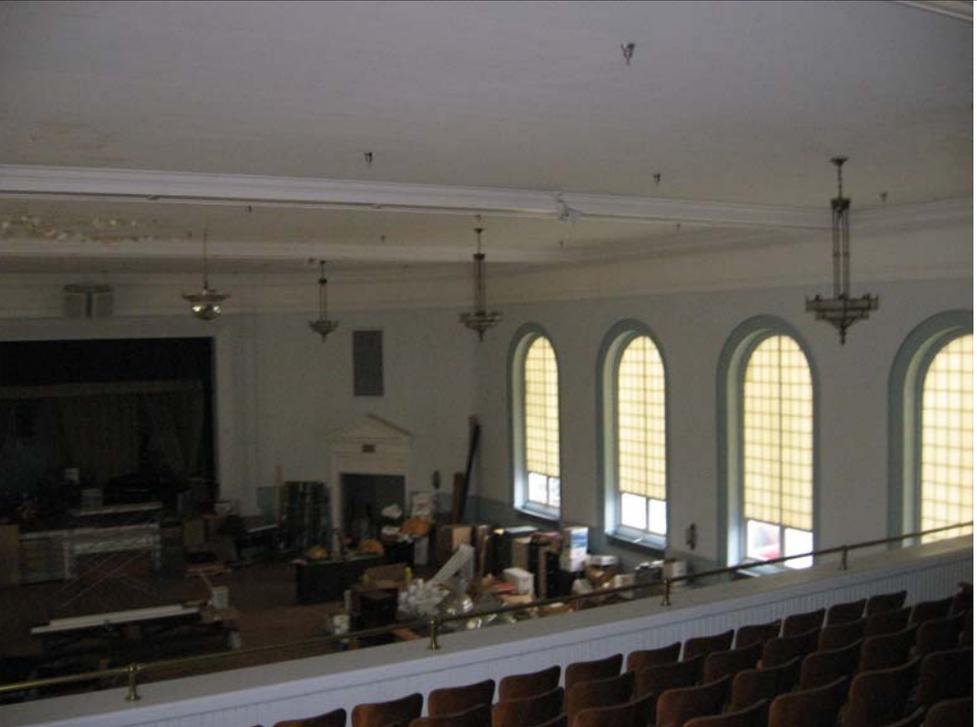
Tighe&Bond		PHOTOGRAPHIC LOG	
Client Name: City of Gardner, MA		Site Location: Perry Auditorium, Gardner, MA	Project No. G-0384
Photo No. 20	Date: 11/25/09

Direction Photo Taken:			
Description: Auditorium lighting

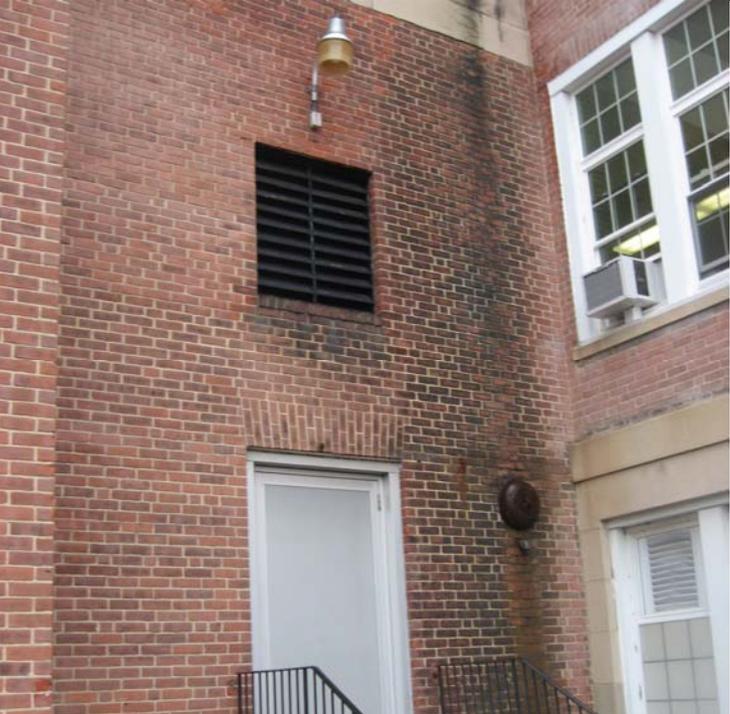
Tighe&Bond		PHOTOGRAPHIC LOG	
Client Name: City of Gardner, MA		Site Location: Perry Auditorium, Gardner, MA	Project No. G-0384
Photo No. 21	Date: 11/25/09

Direction Photo Taken:			
Description: Exterior egress lighting and intake louver for air handler

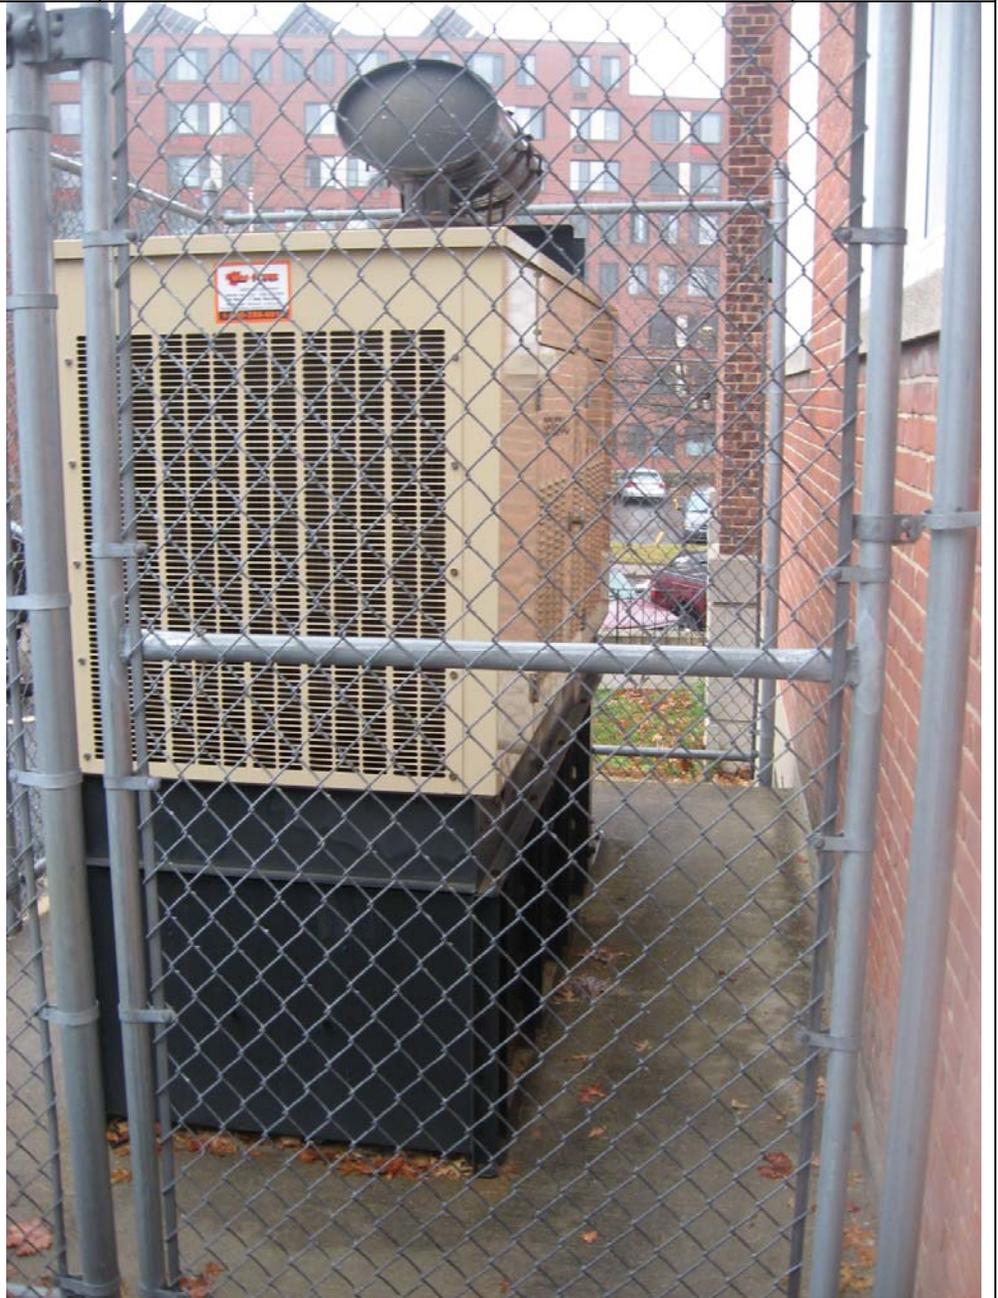
Photo No.
22**Date:**
11/25/09**Direction Photo Taken:****Description:**

Municipal building standby generator

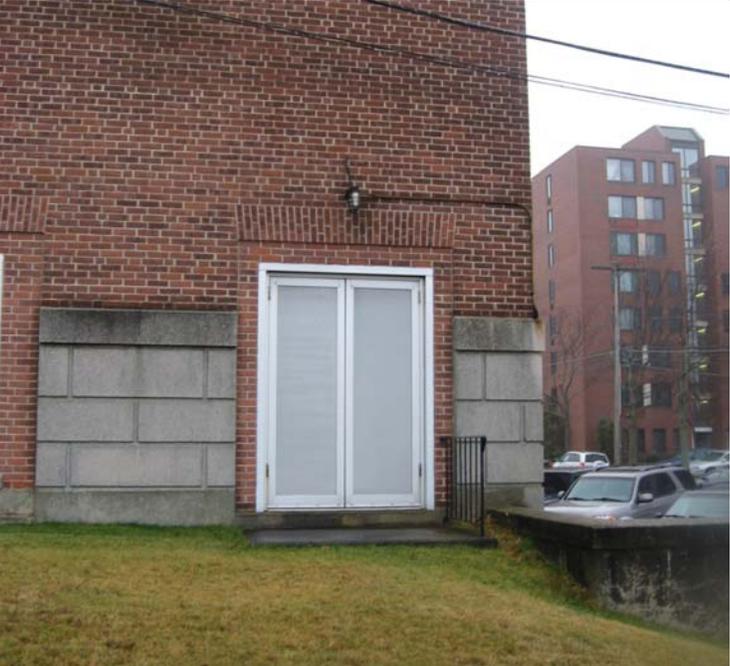
Tighe&Bond		PHOTOGRAPHIC LOG	
Client Name: City of Gardner, MA		Site Location: Perry Auditorium, Gardner, MA	Project No. G-0384
Photo No. 23	Date: 11/25/09

Direction Photo Taken:			
Description: Exterior egress lighting

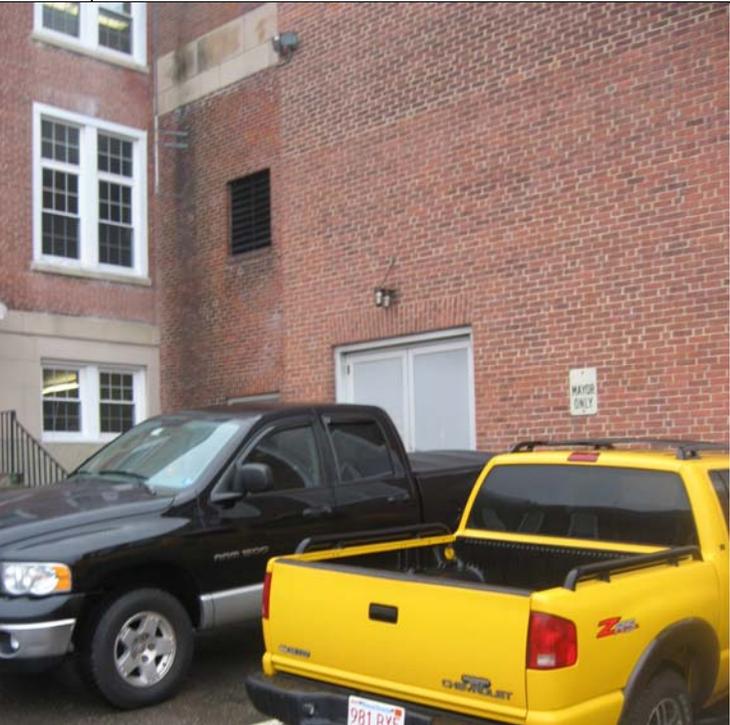
Tighe&Bond		PHOTOGRAPHIC LOG	
Client Name: City of Gardner, MA		Site Location: Perry Auditorium, Gardner, MA	Project No. G-0384
Photo No. 24	Date: 11/25/09

Direction Photo Taken:			
Description: Exterior egress lighting

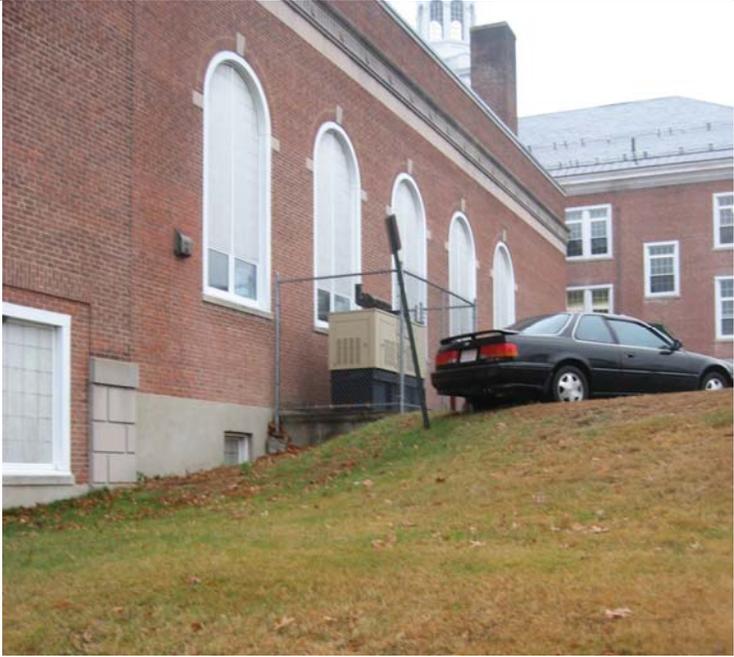
Tighe&Bond		PHOTOGRAPHIC LOG	
Client Name: City of Gardner, MA		Site Location: Perry Auditorium, Gardner, MA	Project No. G-0384
Photo No. 25	Date: 11/25/09

Direction Photo Taken:			
Description: Municipal building standby generator

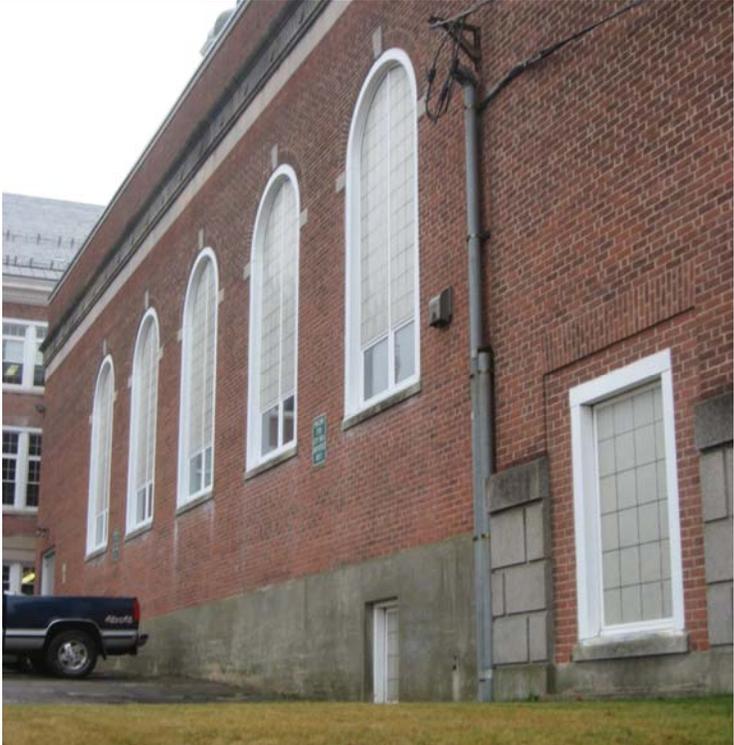
Tighe&Bond		PHOTOGRAPHIC LOG	
Client Name: City of Gardner, MA		Site Location: Perry Auditorium, Gardner, MA	Project No. G-0384
Photo No. 26	Date: 11/25/09

Direction Photo Taken:			
Description: Electrical service entrance

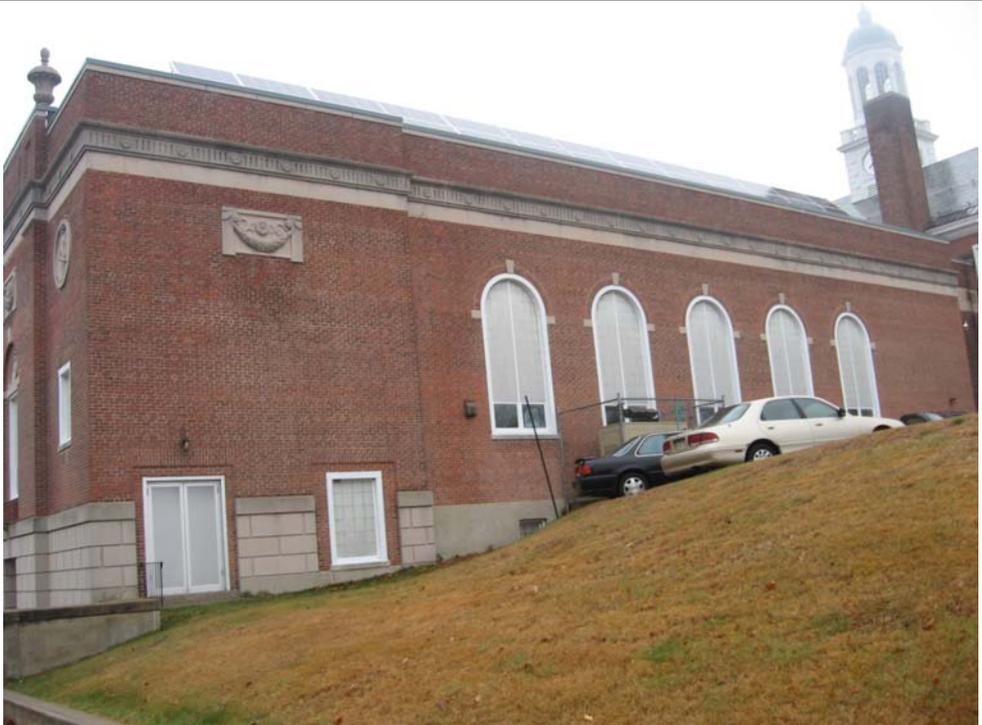
Tighe&Bond		PHOTOGRAPHIC LOG	
Client Name: City of Gardner, MA		Site Location: Perry Auditorium, Gardner, MA	Project No. G-0384
Photo No. 27	Date: 11/25/09

Direction Photo Taken:			
Description: Photo voltaic array

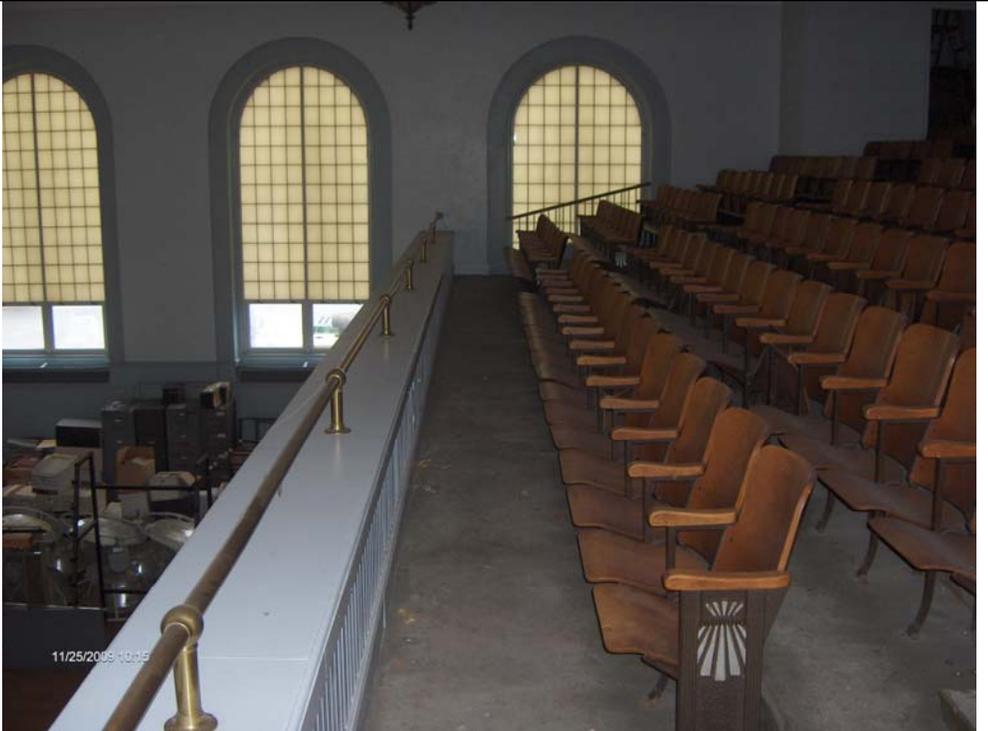
Tighe&Bond		PHOTOGRAPHIC LOG	
Client Name: City of Gardner, MA		Site Location: Perry Auditorium, Gardner, MA	Project No. G-0384
Photo No. 3	Date: 11/25/09

Direction Photo Taken:			
Description: Existing mezzanine

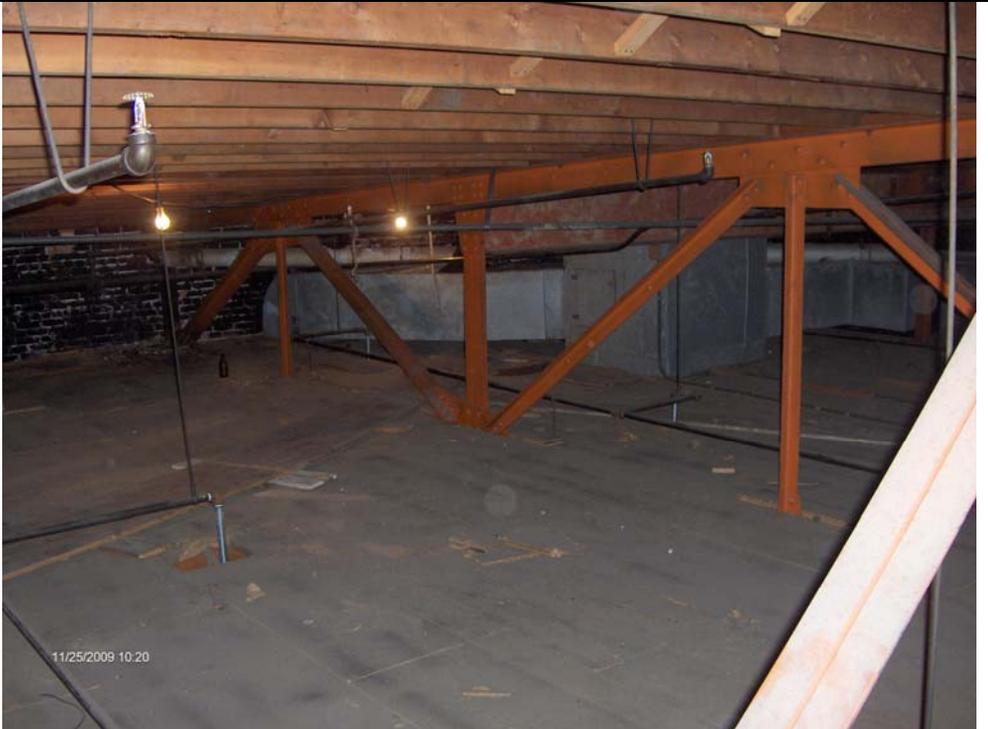
Tighe&Bond		PHOTOGRAPHIC LOG	
Client Name: City of Gardner, MA		Site Location: Perry Auditorium, Gardner, MA	Project No. G-0384
Photo No. 4	Date: 11/25/09

Direction Photo Taken:			
Description: Existing roof trusses and framing

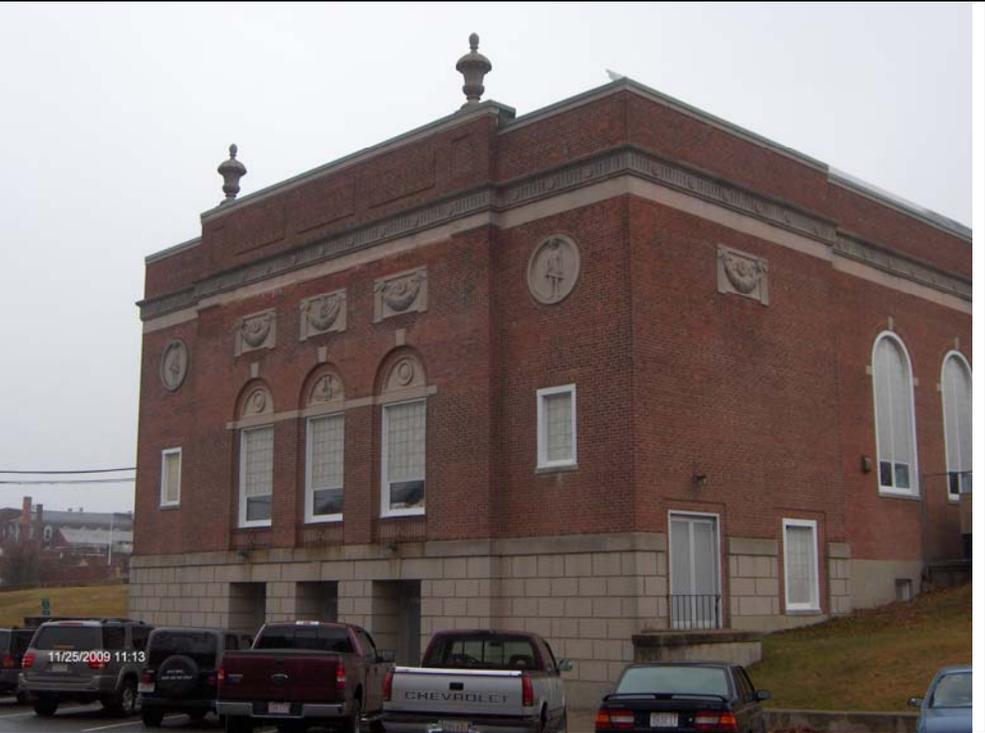
Tighe&Bond		PHOTOGRAPHIC LOG	
Client Name: City of Gardner, MA		Site Location: Perry Auditorium, Gardner, MA	Project No. G-0384
Photo No. 7	Date: 11/25/09

Direction Photo Taken:			
Description: Exterior of west entry

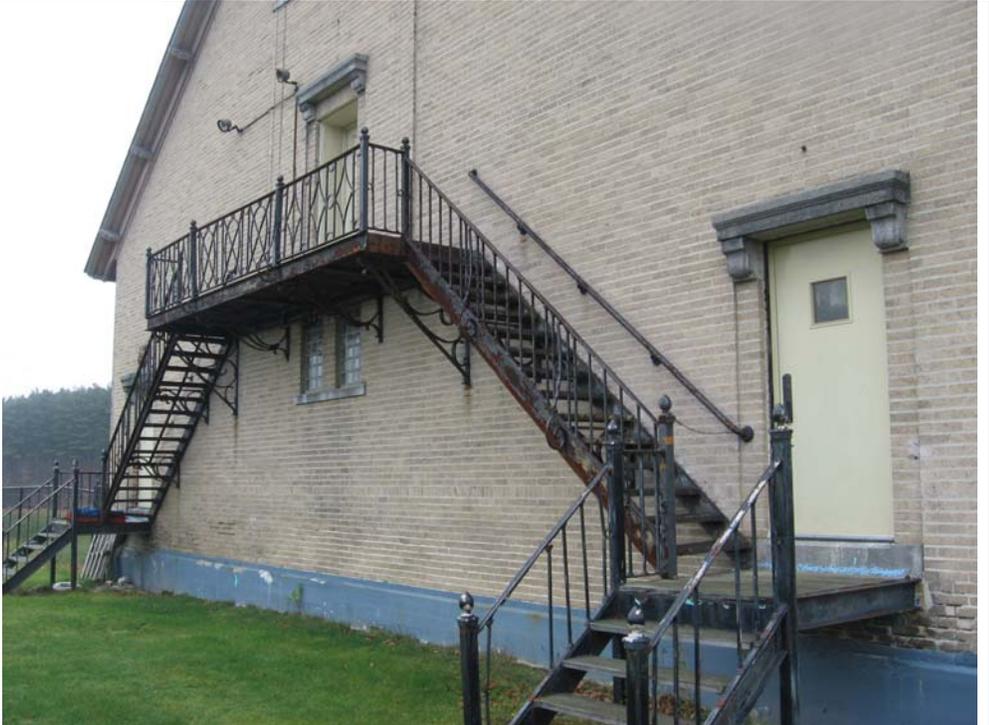
Tighe&Bond		PHOTOGRAPHIC LOG	
Client Name: City of Gardner, MA		Site Location: Greenwood Memorial Bathhouse, Gardner, MA	Project No. G-0384
Photo No. 1	Date: 11/25/09

Direction Photo Taken:			
Description: Exterior egress lighting

There are no emergency or exit lights present in the basement, first floor entranceway, upper and lower pool areas, or the second floor near the entrance. There are no emergency lights in women's or men's lavatory and locker rooms or on the exterior of the building. These lighting fixtures need to be installed throughout the Greenwood Memorial Bathhouse building.

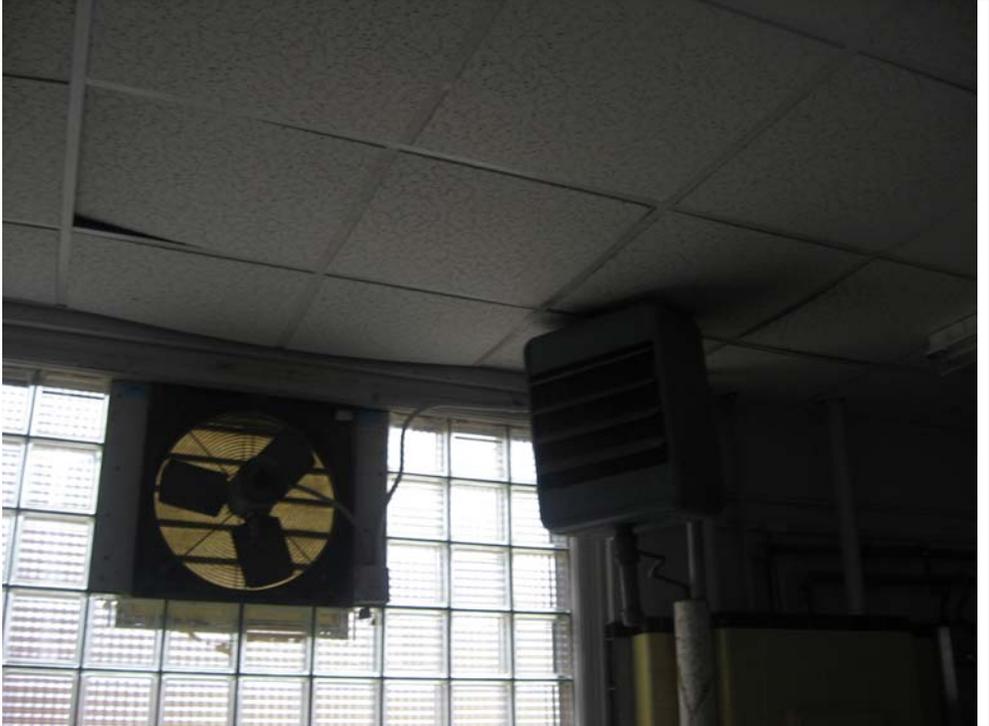
Tighe&Bond		PHOTOGRAPHIC LOG	
Client Name: City of Gardner, MA		Site Location: Greenwood Memorial Bathhouse, Gardner, MA	Project No. G-0384
Photo No. 2	Date: 11/25/09

Direction Photo Taken:			
Description: Men's room ventilation and unit heater

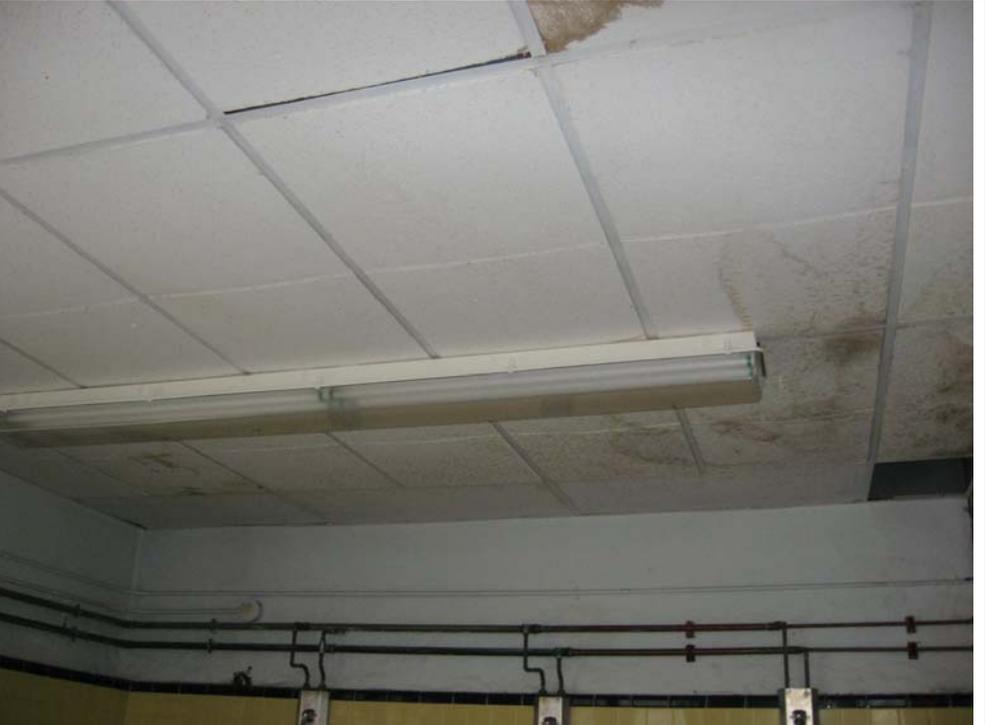
Tighe&Bond		PHOTOGRAPHIC LOG	
Client Name: City of Gardner, MA		Site Location: Greenwood Memorial Bathhouse, Gardner, MA	Project No. G-0384
Photo No. 3	Date: 11/25/09

Direction Photo Taken:			
Description: Men's room lighting

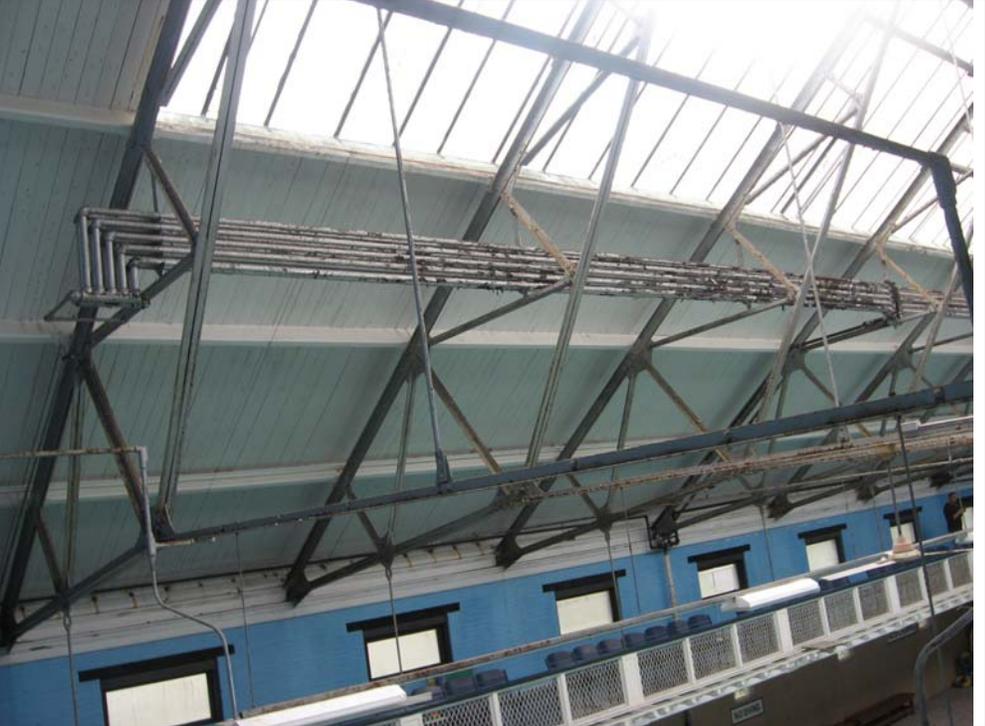
Tighe&Bond		PHOTOGRAPHIC LOG	
Client Name: City of Gardner, MA		Site Location: Greenwood Memorial Bathhouse, Gardner, MA	Project No. G-0384
Photo No. 4	Date: 11/25/09

Direction Photo Taken:			
Description: Pool area radiant heat
