Perry Auditorium and
Greenwood Memorial Bathhouse
Gardner, MA

Final Building Assessment Report

**The City of Gardner
Massachusetts**

March 2010

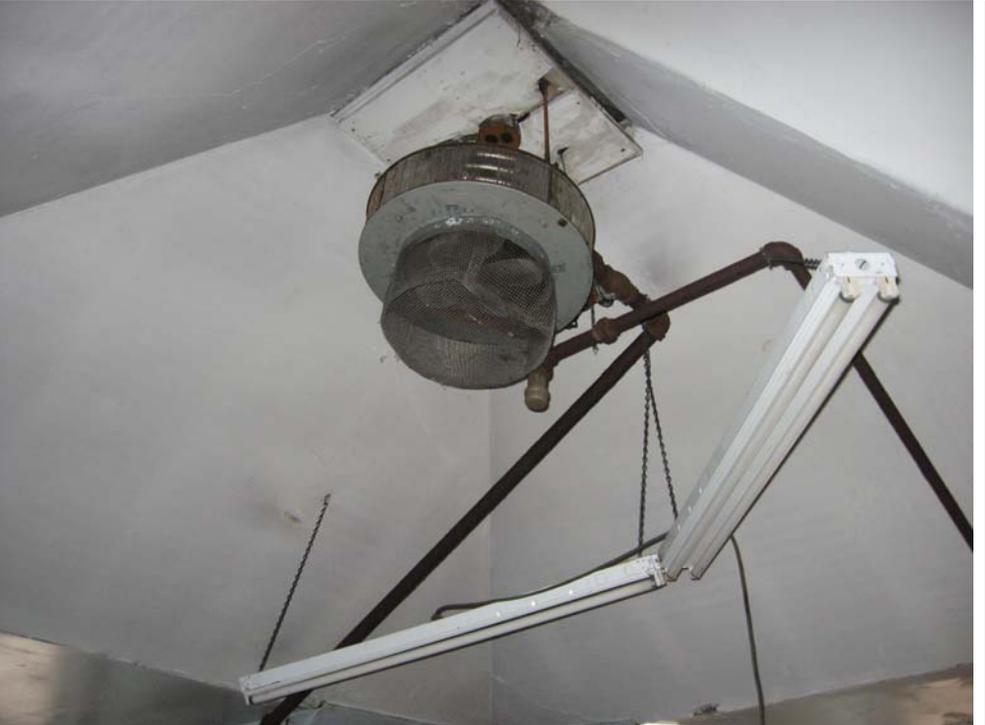
Tighe&Bond		PHOTOGRAPHIC LOG	
Client Name: City of Gardner, MA		Site Location: Greenwood Memorial Bathhouse, Gardner, MA	Project No. G-0384
Photo No. 5	Date: 11/25/09

Direction Photo Taken:			
Description: Second floor unit heater and area lighting

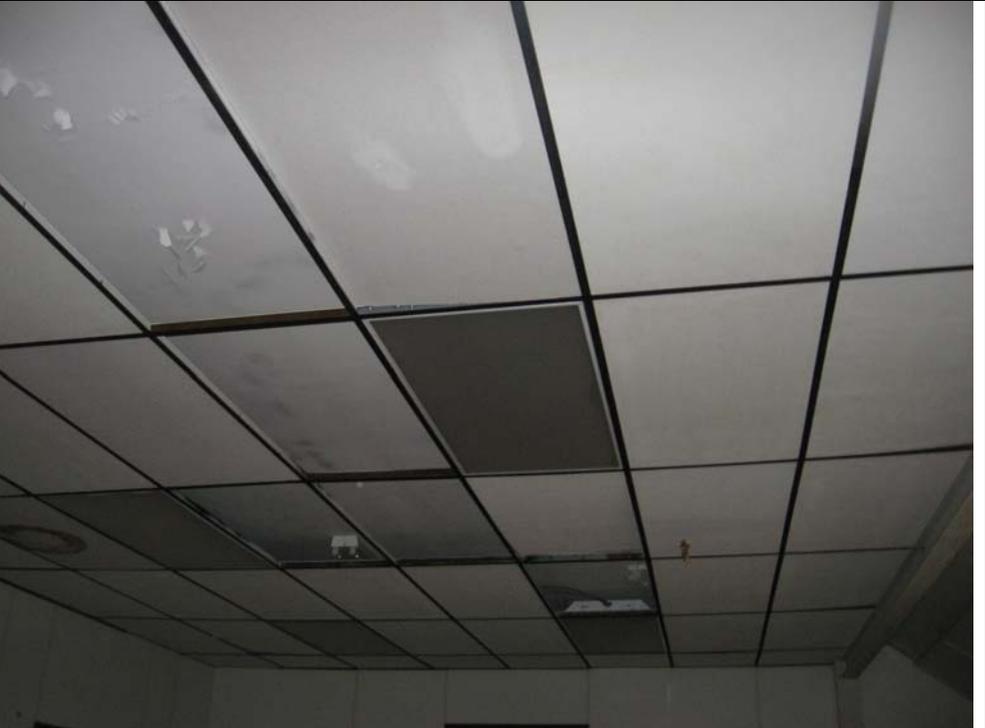
Tighe&Bond		PHOTOGRAPHIC LOG	
Client Name: City of Gardner, MA		Site Location: Greenwood Memorial Bathhouse, Gardner, MA	Project No. G-0384
Photo No. 6	Date: 11/25/09

Direction Photo Taken:			
Description: Second floor lighting

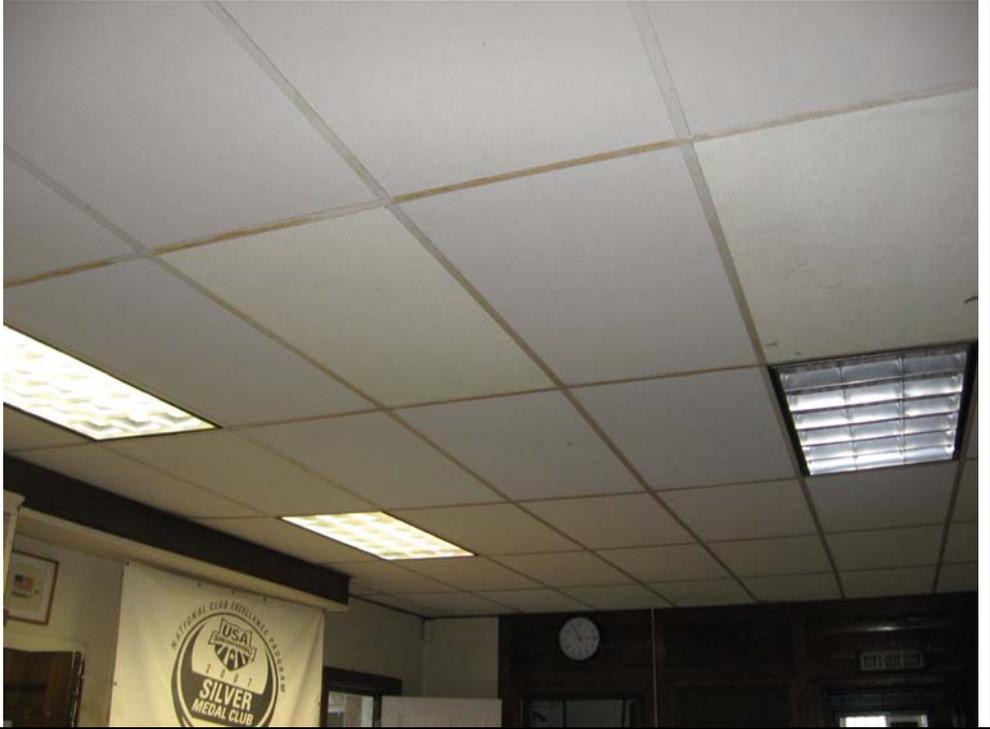
Tighe&Bond		PHOTOGRAPHIC LOG	
Client Name: City of Gardner, MA		Site Location: Greenwood Memorial Bathhouse, Gardner, MA	Project No. G-0384
Photo No. 7	Date: 11/25/09

Direction Photo Taken:			
Description: Entrance area lighting

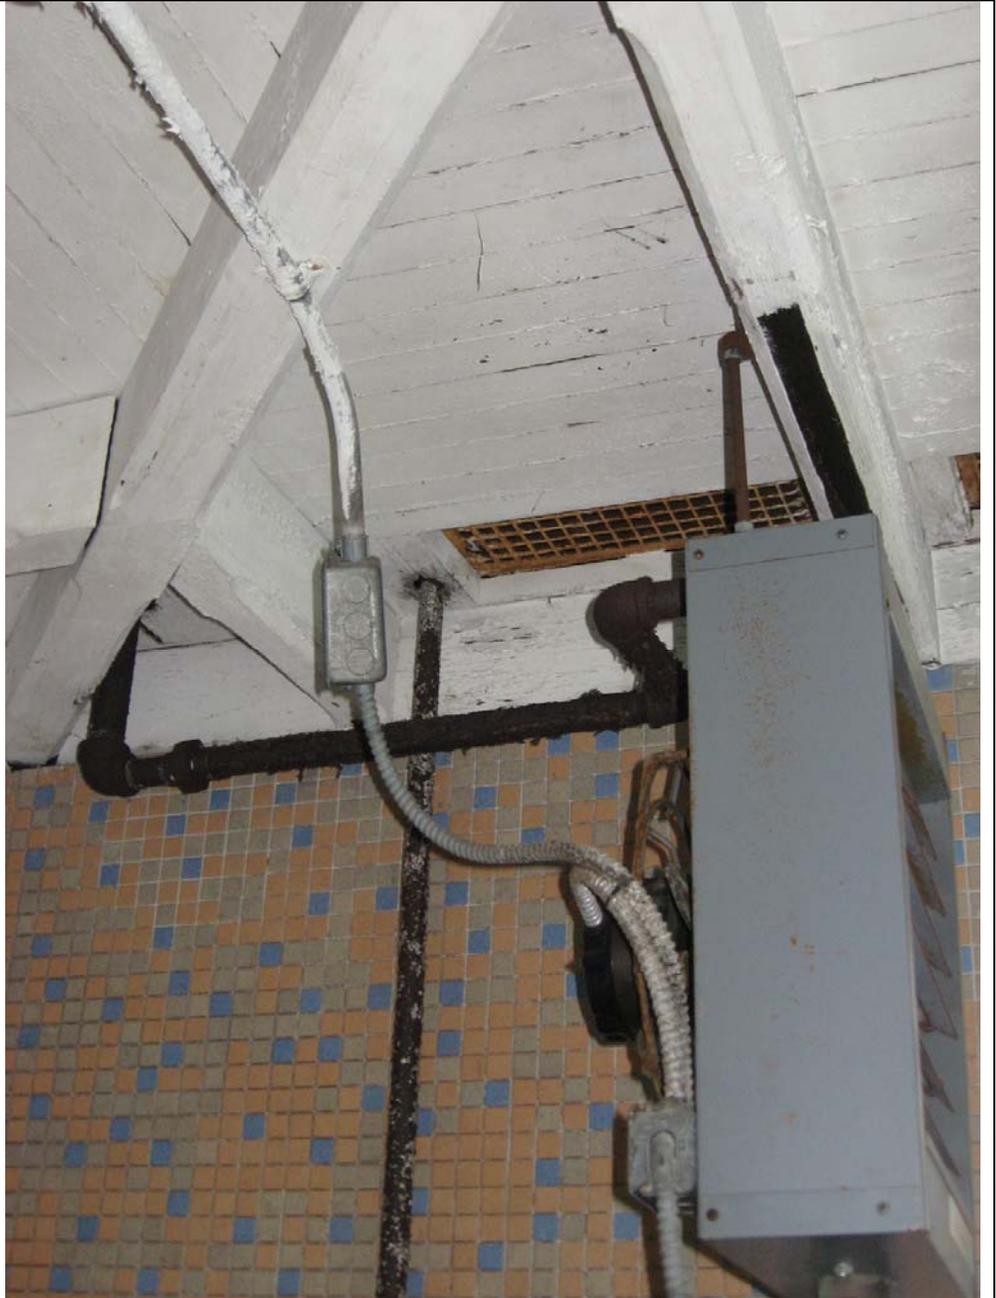
Photo No.
8**Date:**
11/25/09**Direction Photo Taken:****Description:**

Unit heater and lighting for heater

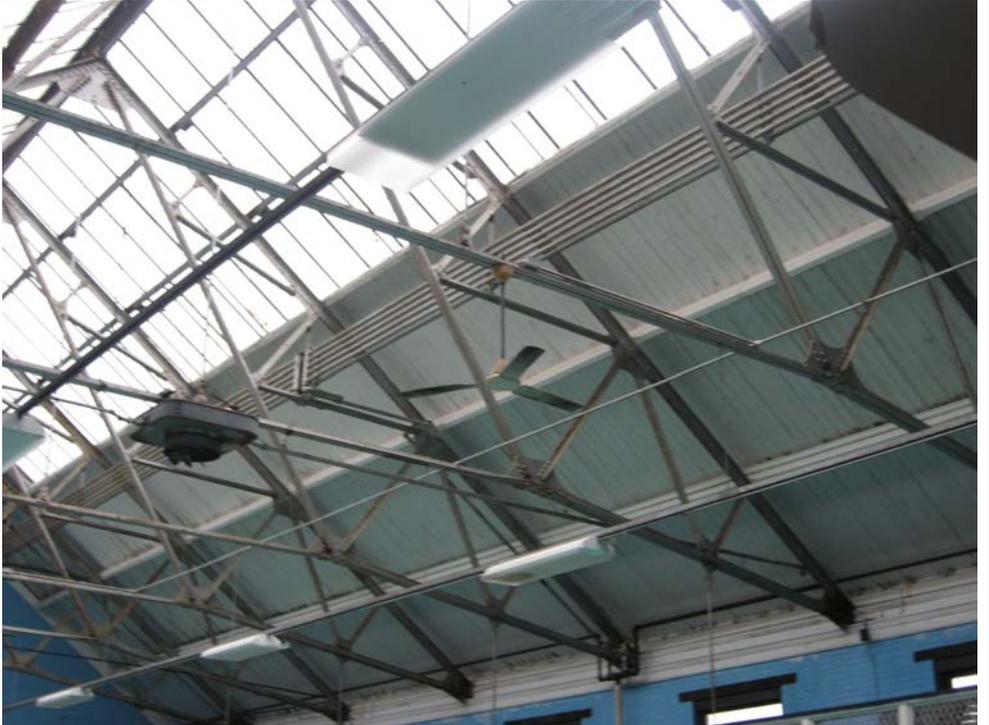
Tighe&Bond		PHOTOGRAPHIC LOG	
Client Name: City of Gardner, MA		Site Location: Greenwood Memorial Bathhouse, Gardner, MA	Project No. G-0384
Photo No. 9	Date: 11/25/09

Direction Photo Taken:			
Description: Pool lighting unit heater and pool radiant heat

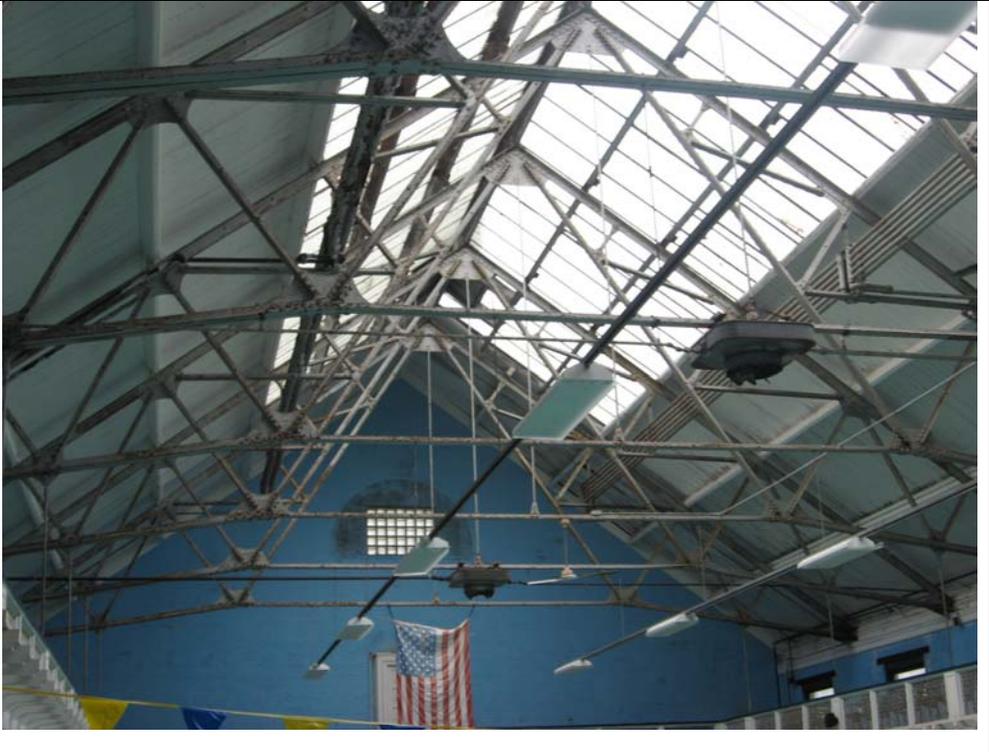
Tighe&Bond		PHOTOGRAPHIC LOG	
Client Name: City of Gardner, MA		Site Location: Greenwood Memorial Bathhouse, Gardner, MA	Project No. G-0384
Photo No. 10	Date: 11/25/09

Direction Photo Taken:			
Description: Pool lighting unit heater and pool radiant heat

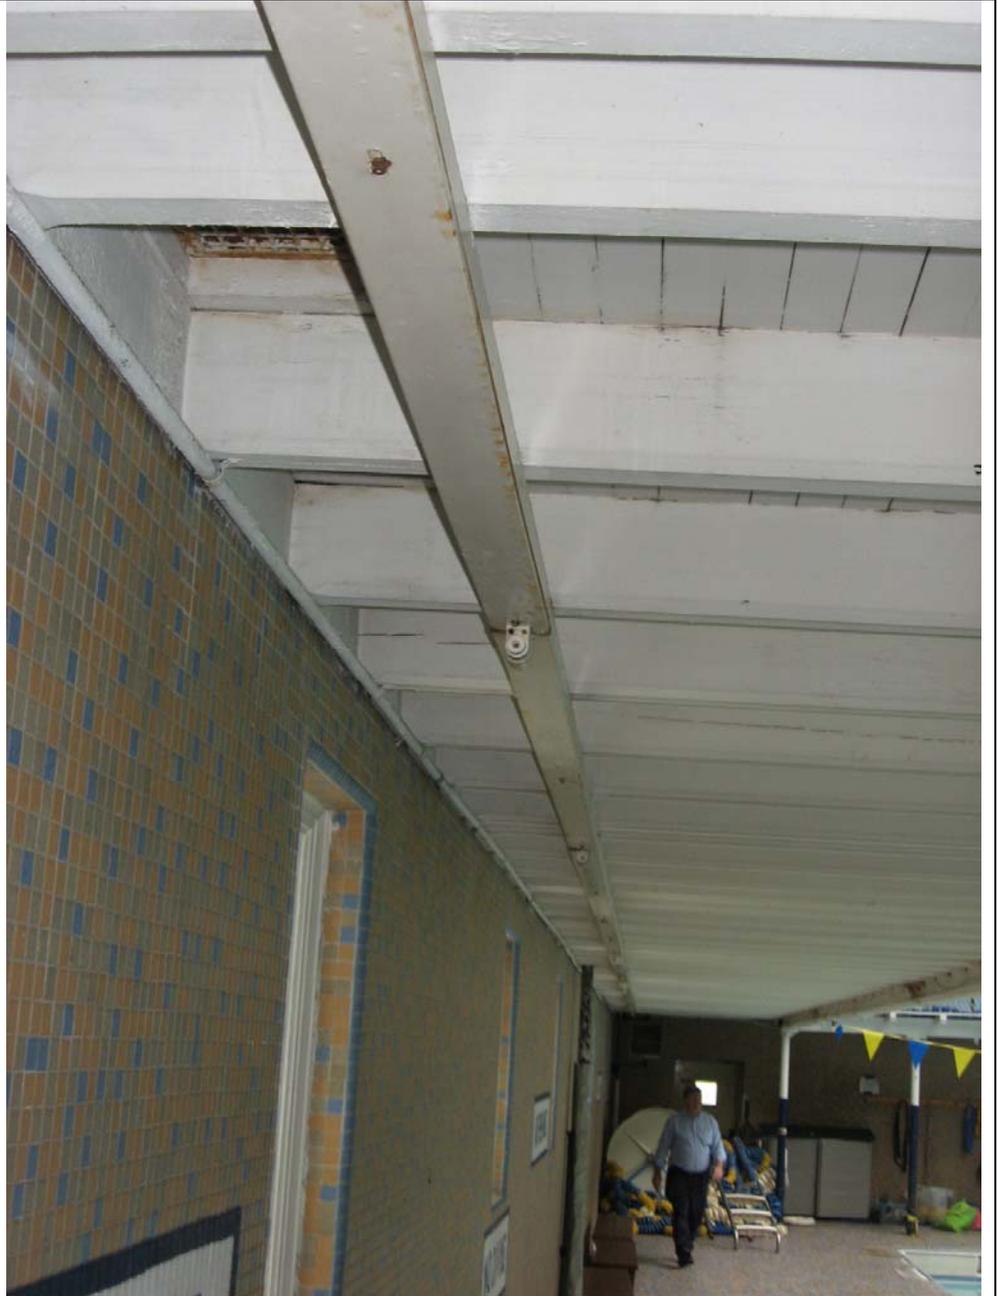
Photo No.
11**Date:**
11/25/09**Direction Photo Taken:****Description:**

Abandoned pool lighting

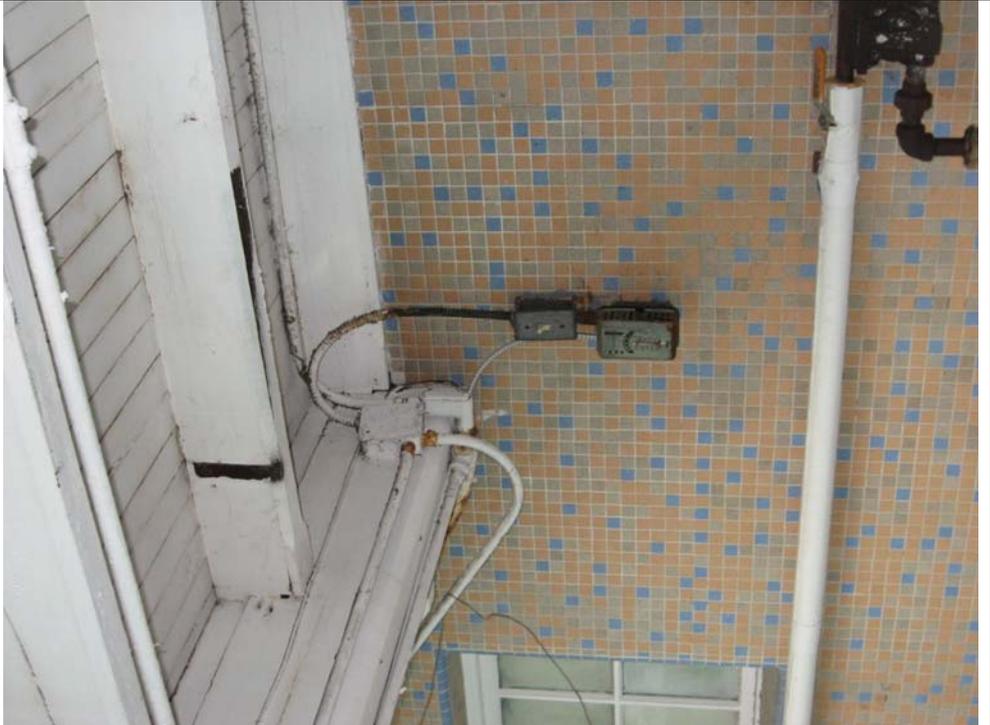
Tighe&Bond		PHOTOGRAPHIC LOG	
Client Name: City of Gardner, MA		Site Location: Greenwood Memorial Bathhouse, Gardner, MA	
		Project No. G-0384	
Photo No. 12	Date: 11/25/09

Direction Photo Taken:			
Description: Branch circuit wiring pool area

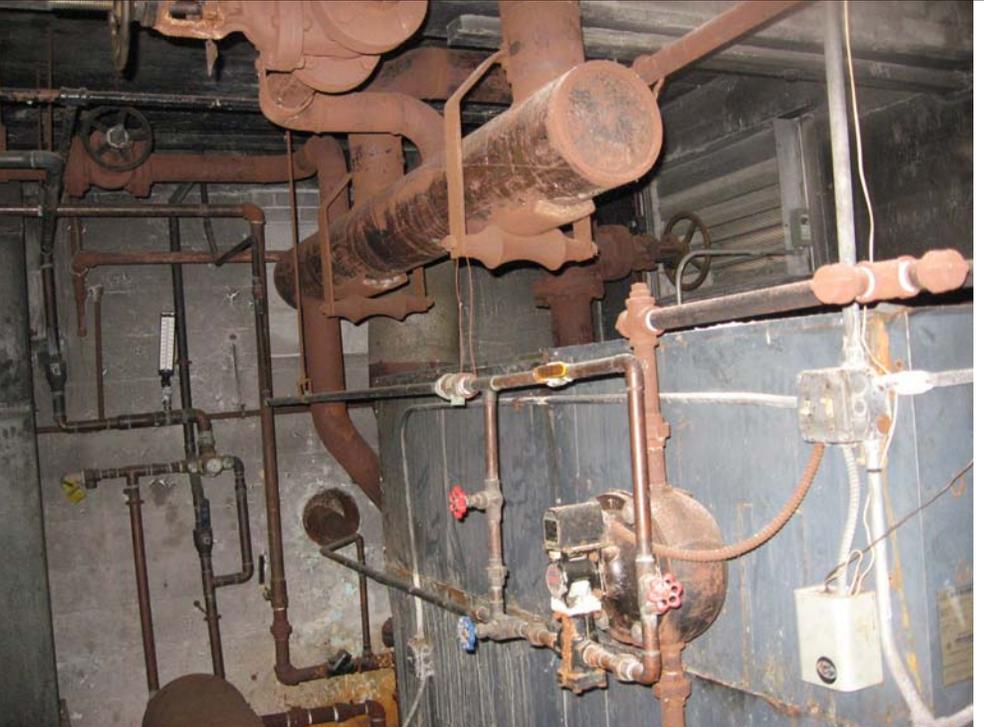
Tighe&Bond		PHOTOGRAPHIC LOG	
Client Name: City of Gardner, MA		Site Location: Greenwood Memorial Bathhouse, Gardner, MA	Project No. G-0384
Photo No. 14	Date: 11/25/09

Direction Photo Taken:			
Description: Building heating plant

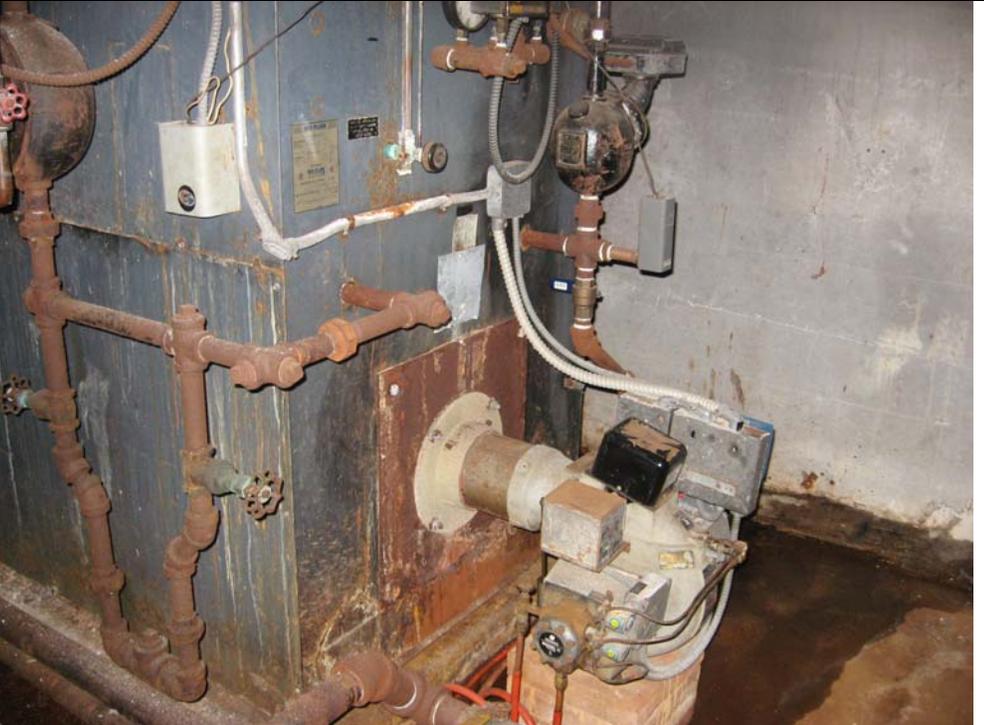
Tighe&Bond		PHOTOGRAPHIC LOG	
Client Name: City of Gardner, MA		Site Location: Greenwood Memorial Bathhouse, Gardner, MA	Project No. G-0384
Photo No. 15	Date: 11/25/09

Direction Photo Taken:			
Description: Building heating plant for building heat and pool water

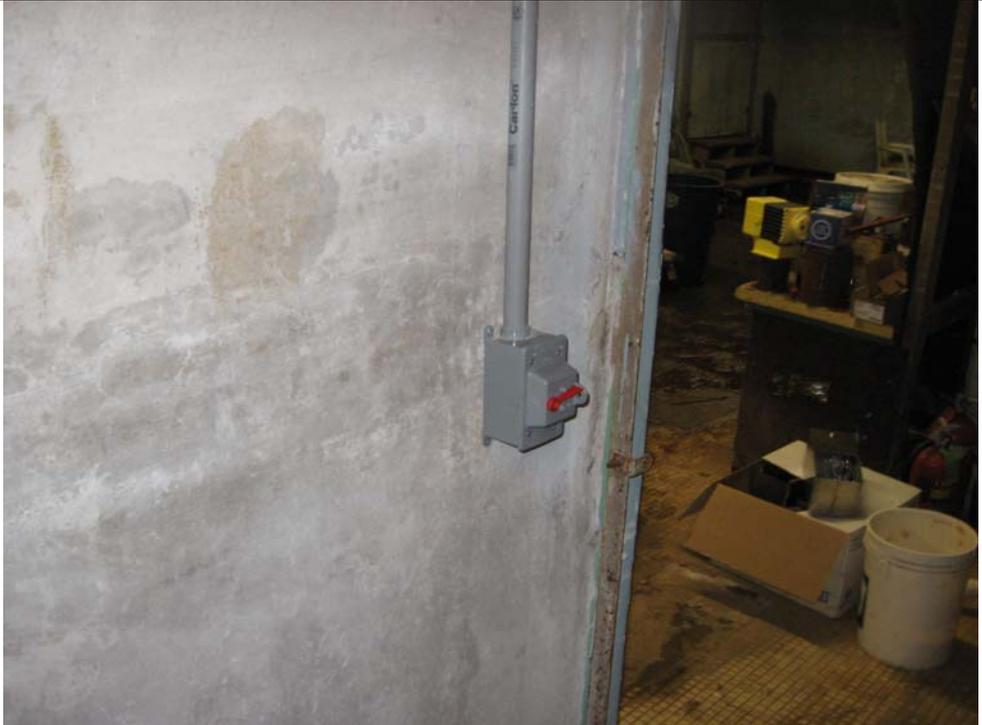
Tighe&Bond		PHOTOGRAPHIC LOG	
Client Name: City of Gardner, MA		Site Location: Greenwood Memorial Bathhouse, Gardner, MA	Project No. G-0384
Photo No. 16	Date: 11/25/09

Direction Photo Taken:			
Description: New branch circuit wiring to basement lighting

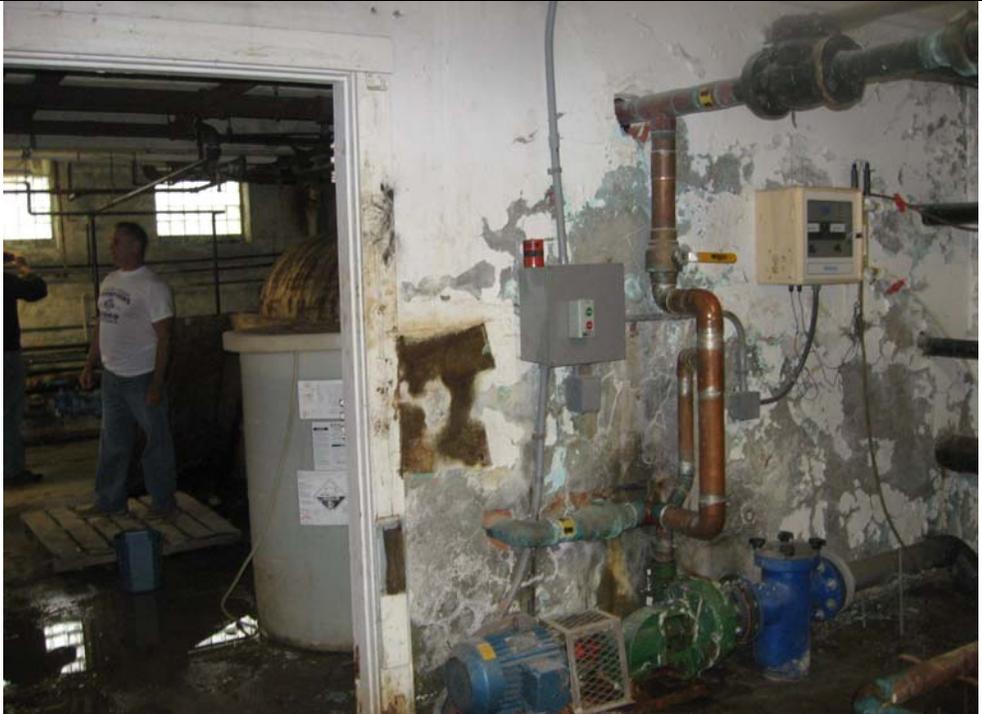
Tighe&Bond		PHOTOGRAPHIC LOG	
Client Name: City of Gardner, MA		Site Location: Greenwood Memorial Bathhouse, Gardner, MA	Project No. G-0384
Photo No. 17	Date: 11/25/09

Direction Photo Taken:			
Description: Pool water pumping

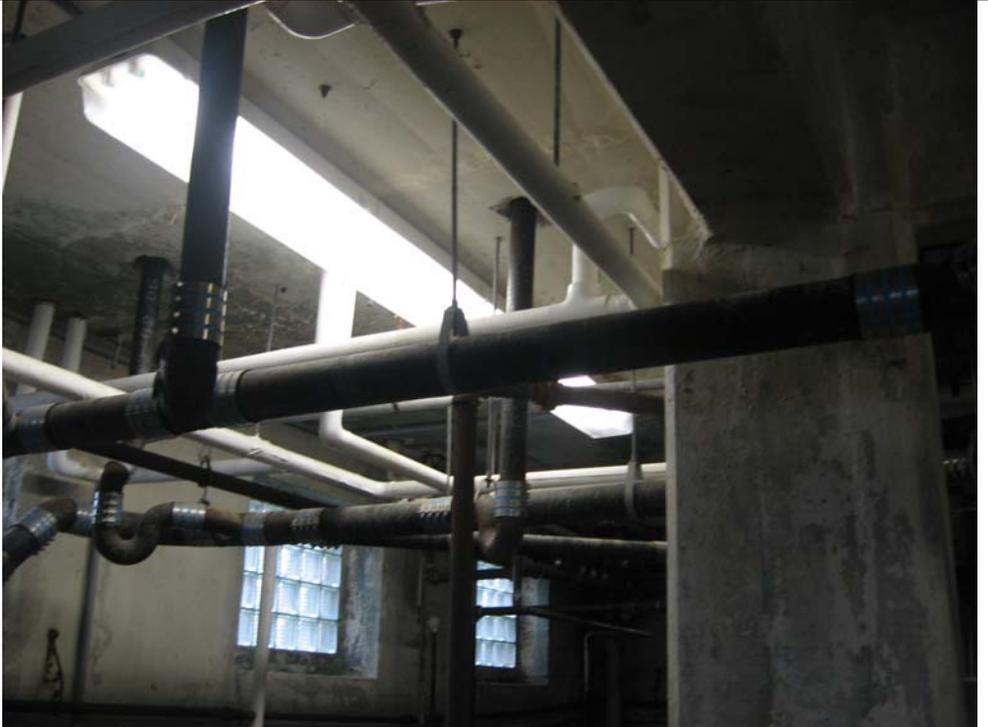
Tighe&Bond		PHOTOGRAPHIC LOG	
Client Name: City of Gardner, MA		Site Location: Greenwood Memorial Bathhouse, Gardner, MA	Project No. G-0384
Photo No. 18	Date: 11/25/09

Direction Photo Taken:			
Description: New lighting in basement

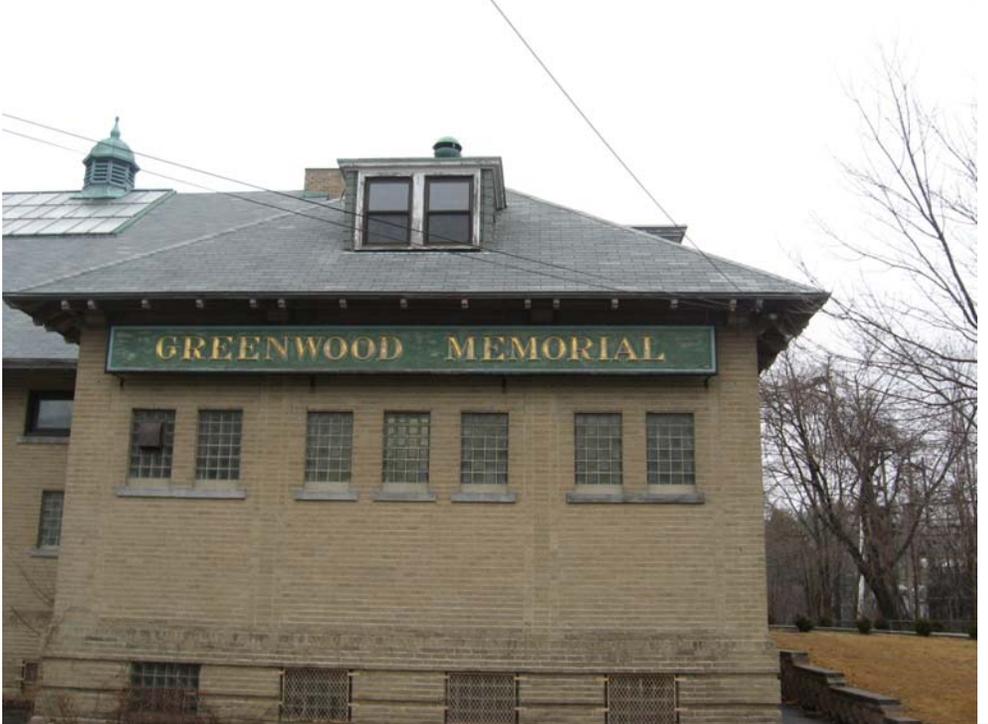
Tighe&Bond		PHOTOGRAPHIC LOG	
Client Name: City of Gardner, MA		Site Location: Greenwood Memorial Bathhouse, Gardner, MA	Project No. G-0384
Photo No. 1	Date: 11/25/09

Direction Photo Taken:			
Description: South side of main entrance

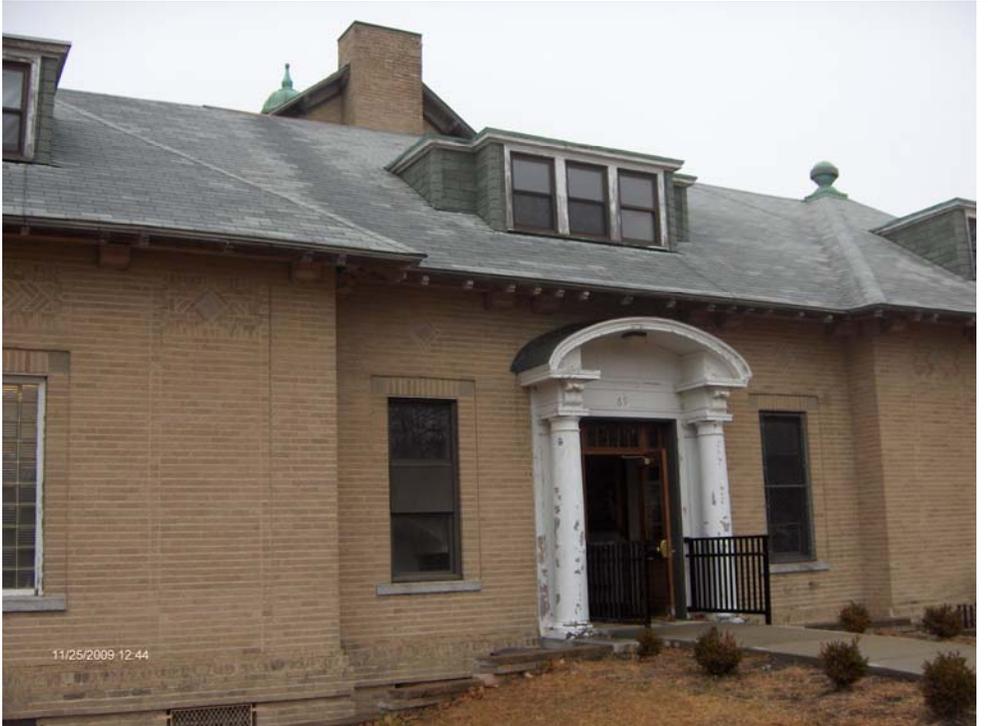
Tighe&Bond		PHOTOGRAPHIC LOG	
Client Name: City of Gardner, MA		Site Location: Greenwood Memorial Bathhouse, Gardner, MA	Project No. G-0384
Photo No. 2	Date: 11/25/09

Direction Photo Taken:			
Description: Main entrance

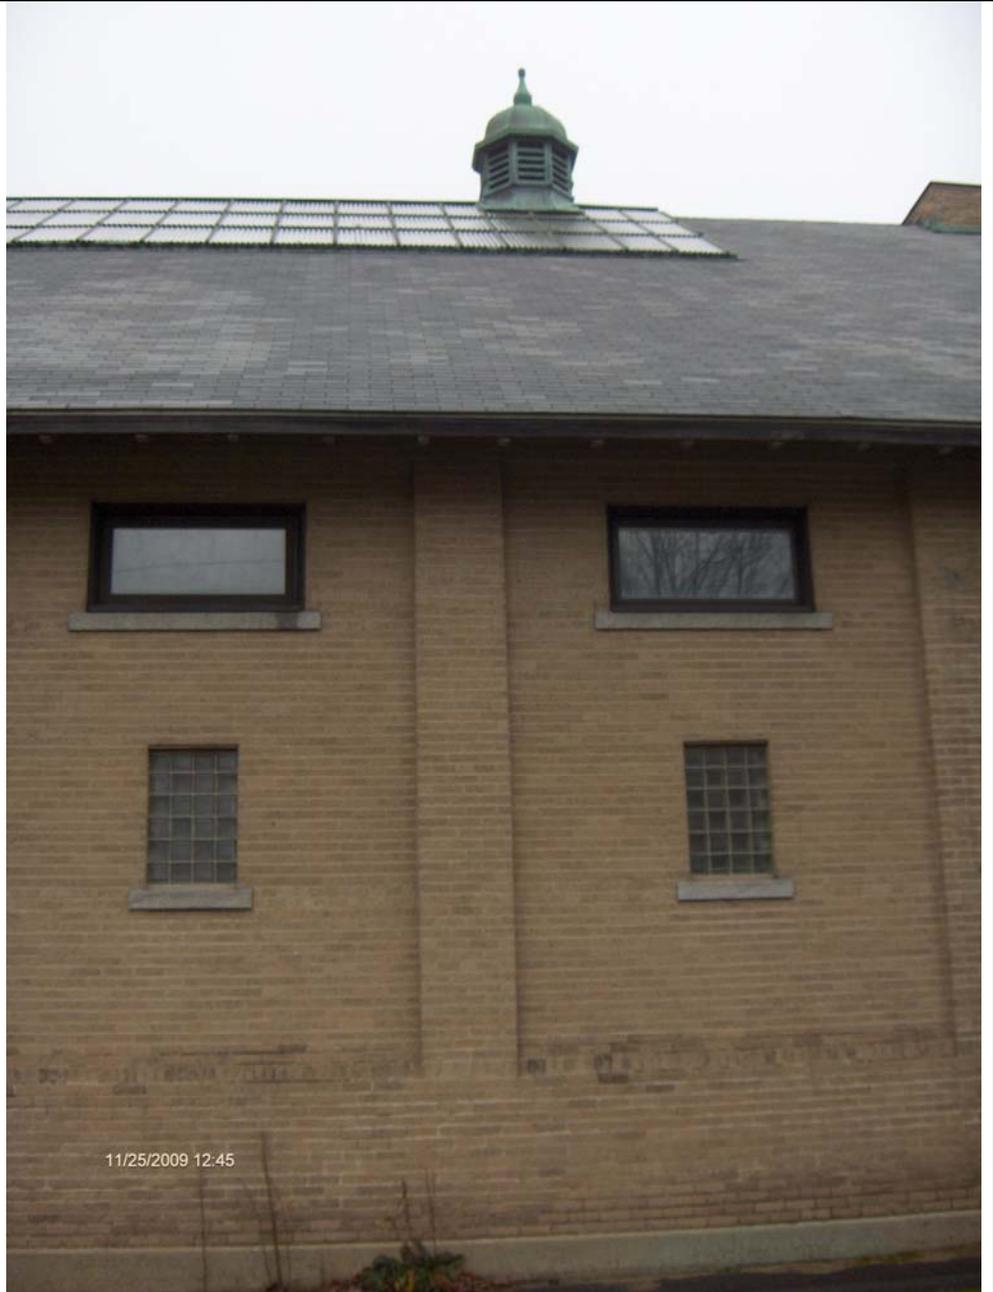
Photo No.
3**Date:**
11/25/09**Direction Photo Taken:****Description:**

South wall elevation

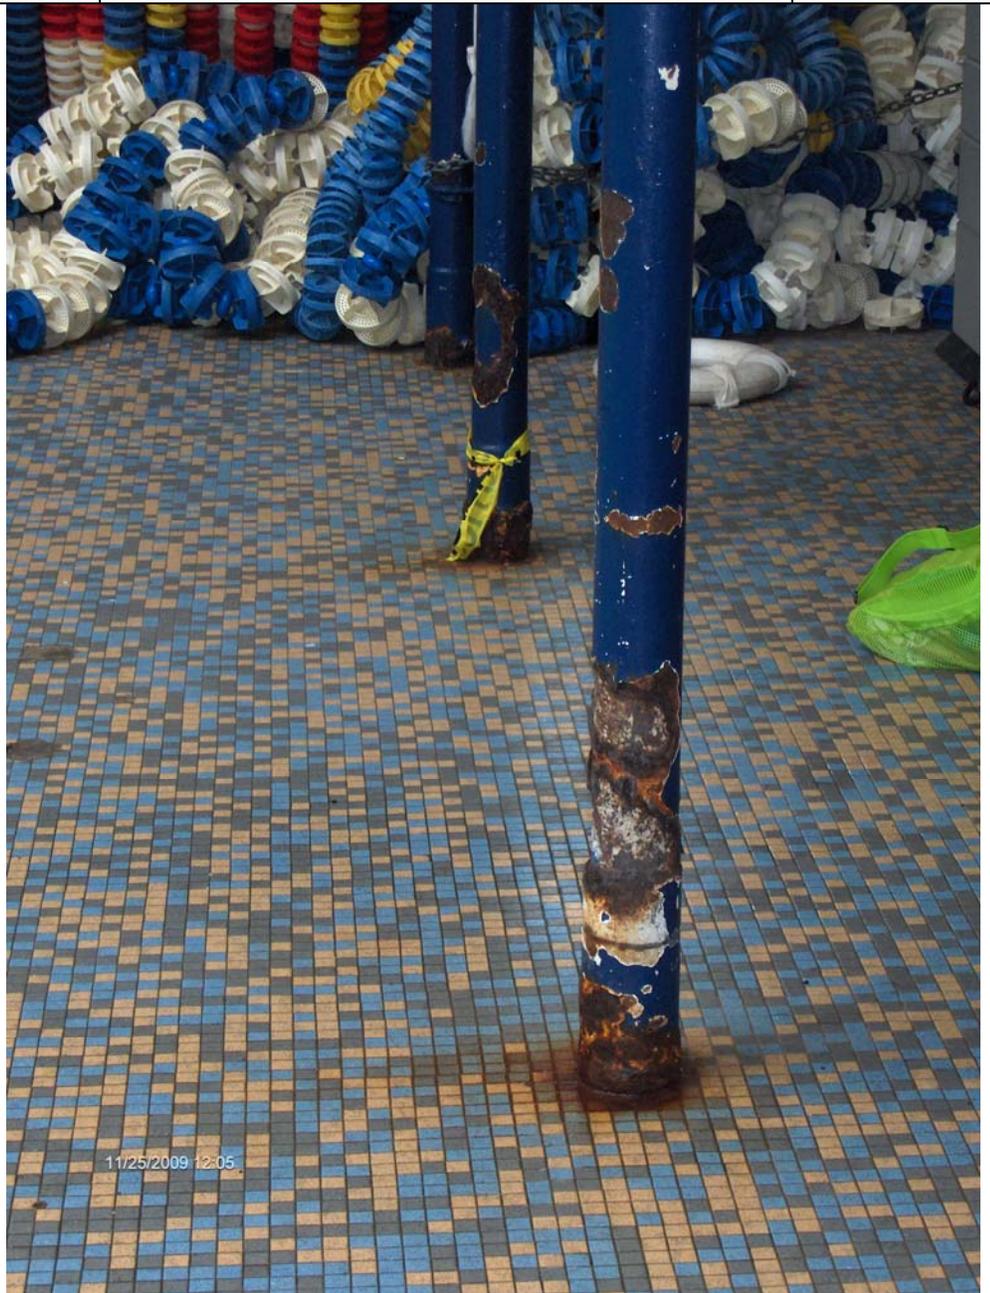
Photo No.
9**Date:**
11/25/09**Direction Photo Taken:****Description:**

Deteriorated base at mezzanine support columns

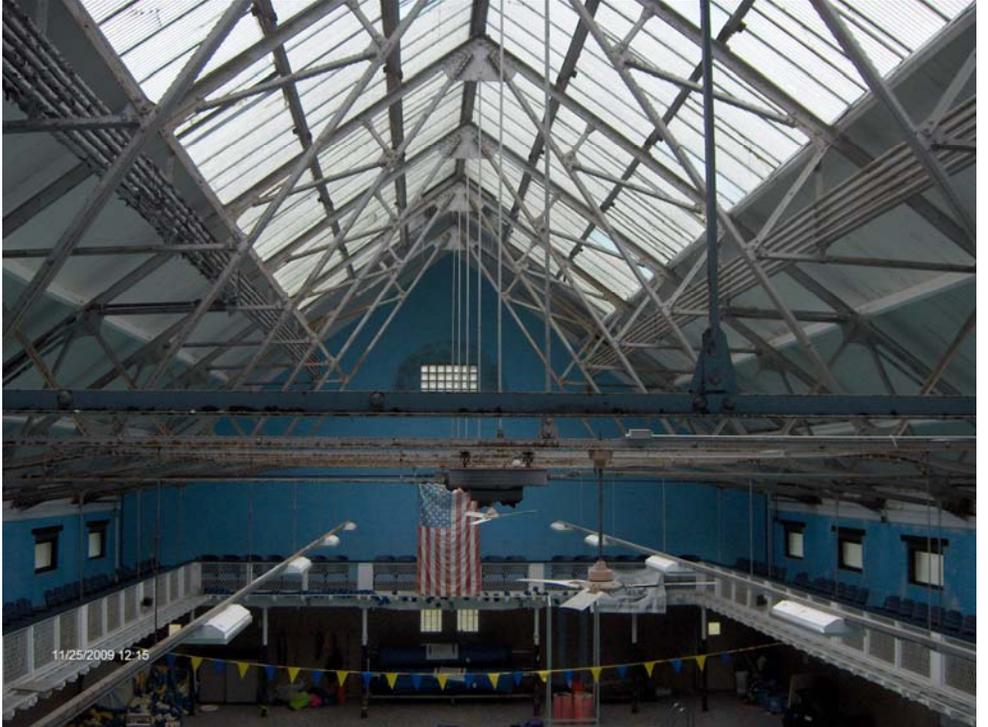
Tighe&Bond		PHOTOGRAPHIC LOG	
Client Name: City of Gardner, MA		Site Location: Greenwood Memorial Bathhouse, Gardner, MA	Project No. G-0384
Photo No. 14	Date: 11/25/09

Direction Photo Taken:			
Description: Roof truss elevation
